The Art of Metal Stitching

Instructions for installing the LC59RB reinforcement brackets on the Cummins 5.9 series 53 block

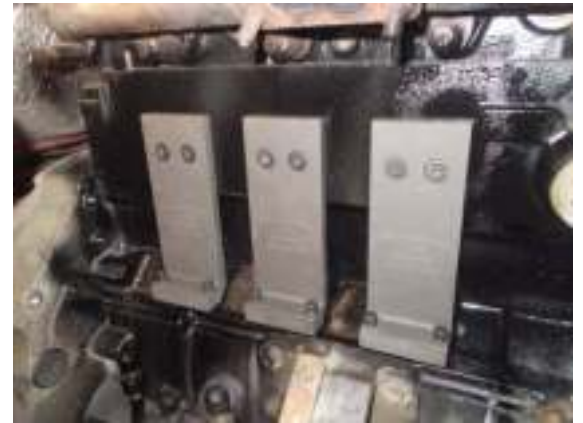
The LC59RB bracket is designed to add strength to the side of the engine block to prevent cracking and/or additional cracking after a metal stitching repair.

This addresses the cause of the cracking problem that we have identified as a slight weakness due to the shape of the block and slow heat transfer to the lower outside wall of the block following cold starting of the engine in some blocks with the # 53 cast on the lower drivers side front corner of the block.

The bracket should be installed immediately after metal stitching the crack.
