GREEN DIESEL
ENGINEERING

2017 GM 2.8L Colorado Engine Failure Analysis

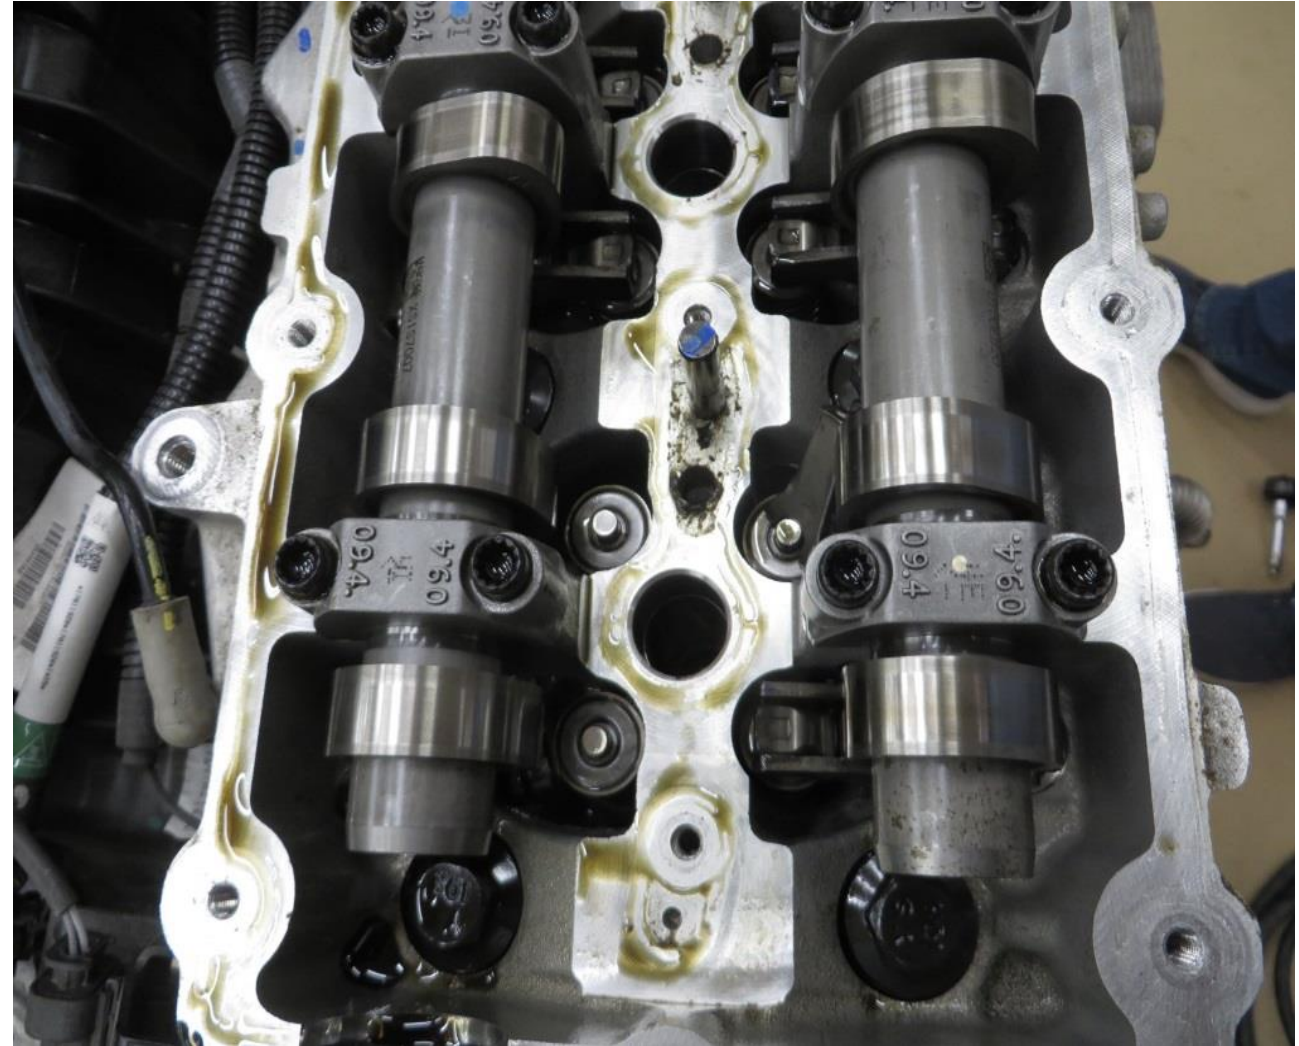
- All four rocker arms on cylinder 4 were broke as shown in photo.
- This indicates hard contact with piston.
- #3 cylinder shows functional rocker arms.

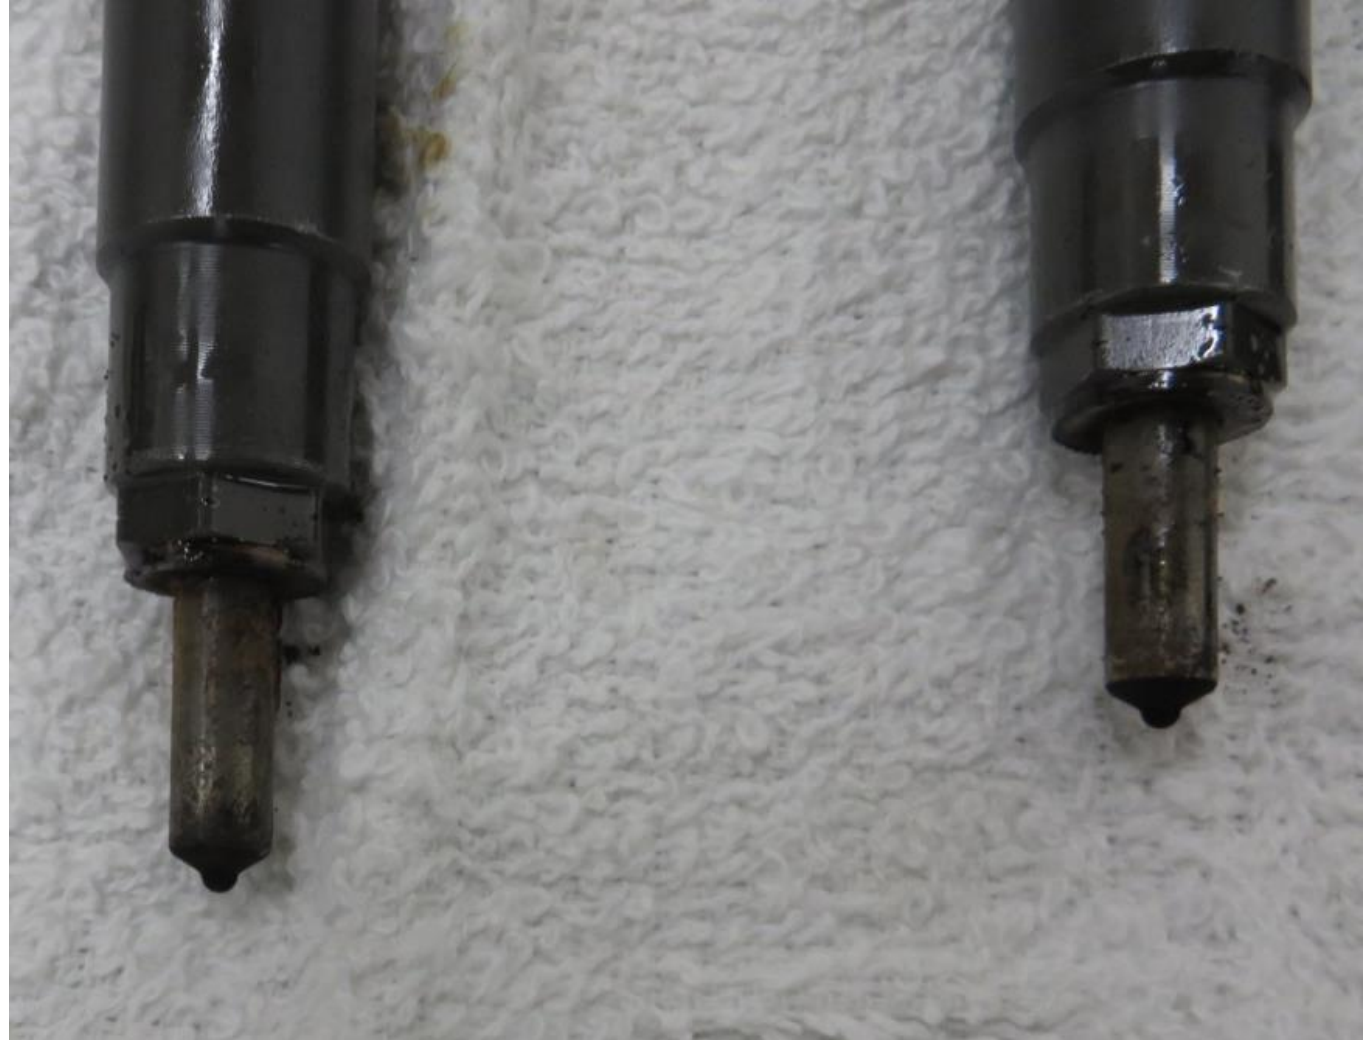
- The head bolts still had proper break-away torque.
- The cylinder head seems in decent shape given the failure mode. It appears two valves are slightly bent from piston contact.
- The head gasket is in good shape and no signs of leakage.
- All four injectors are intact with no signs of tip damage. They still need to be sent out for flow testing.
- The glow plugs are also intact.

- Two injectors tips from engine shown at right.

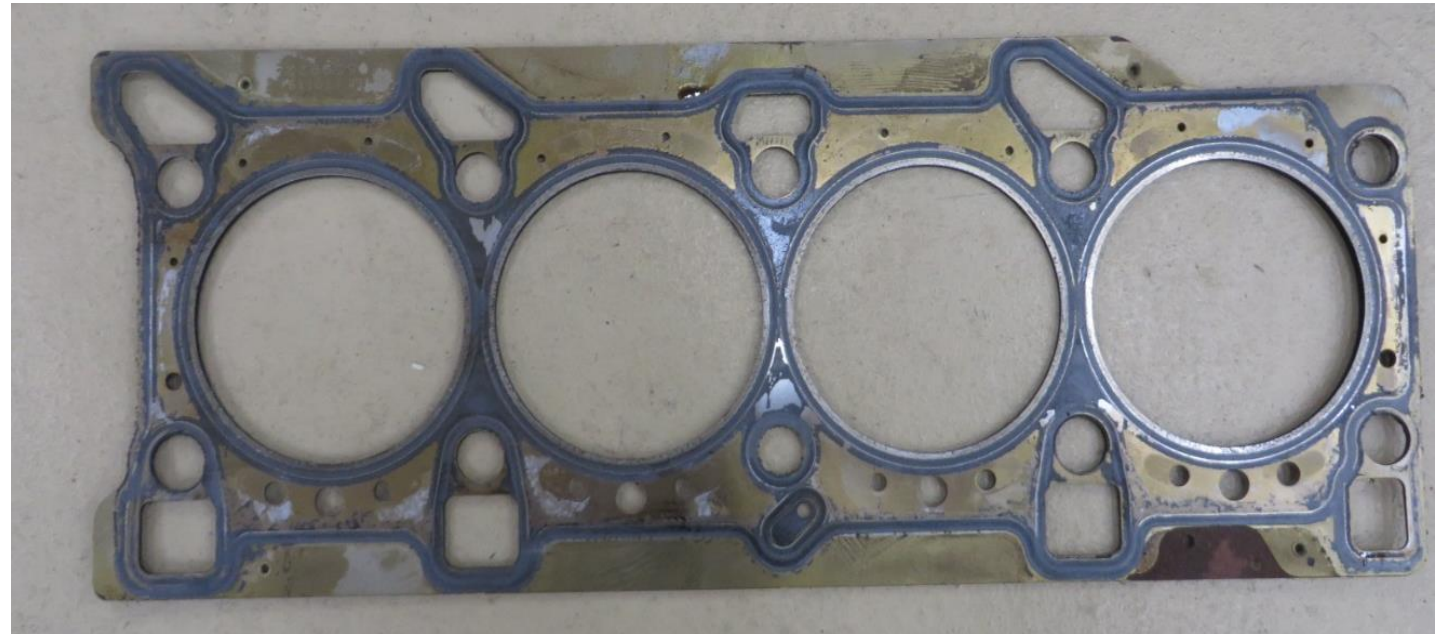
- Head gasket shows no signs of leakage.

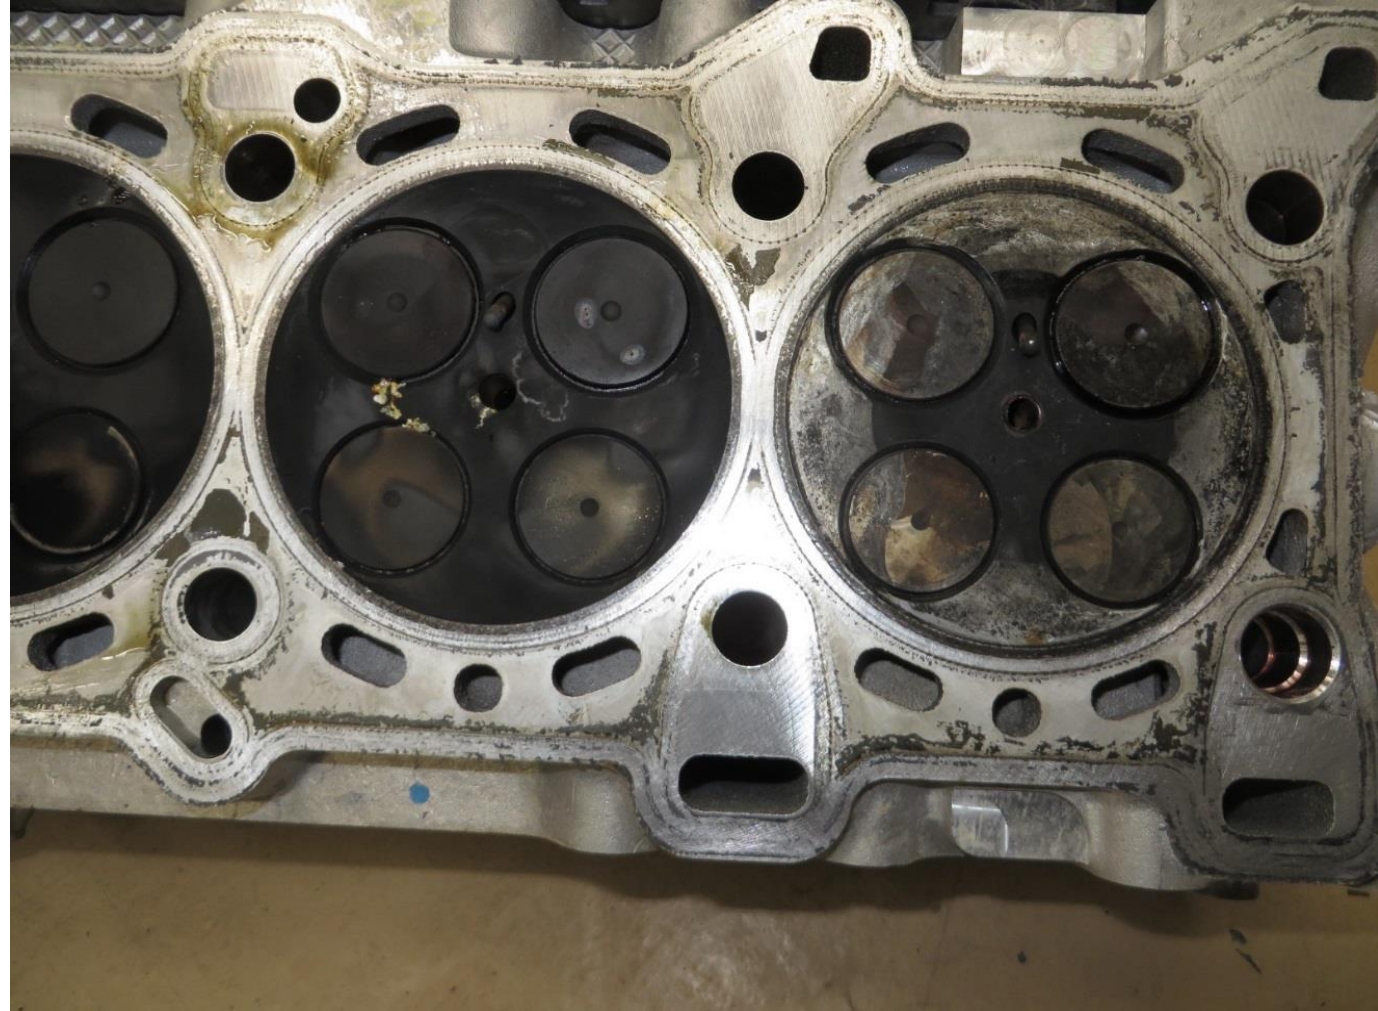
- You can see the impression from the piston getting pushed into the head.
- This indicates failure on the bottom side of the piston as it let go from connecting rod.

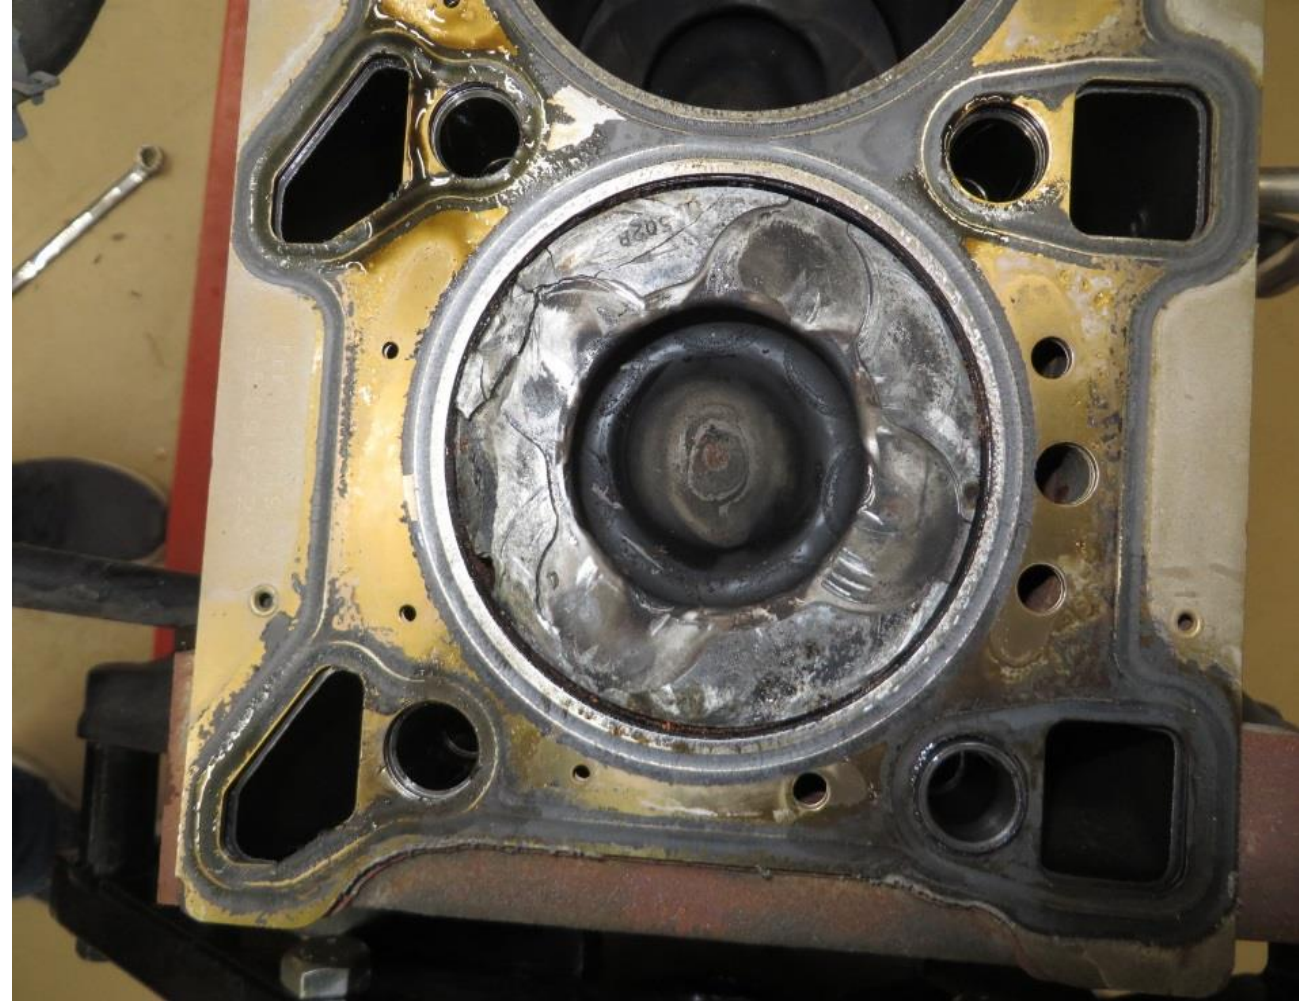
- After removing cylinder head, the piston is visible and still somewhat intact, albeit cracked in many pieces. It fell apart when knocked out of cylinder.
- The other three pistons looked fantastic and show normal wear for a low mileage engine.

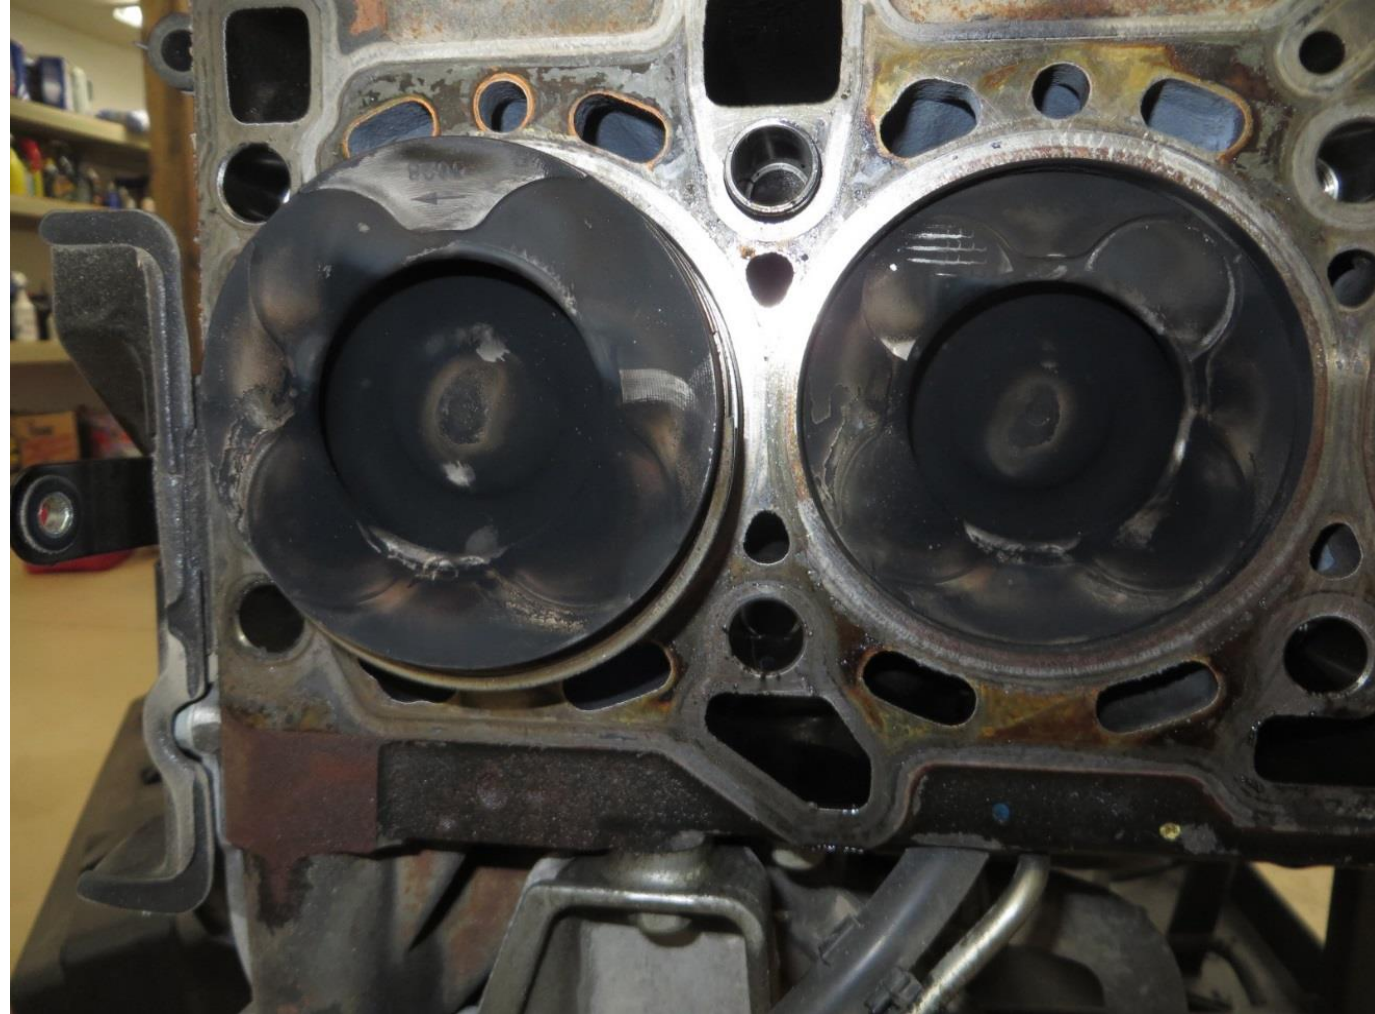
- Cylinders 1 and 2 are in very good shape with normal wear.

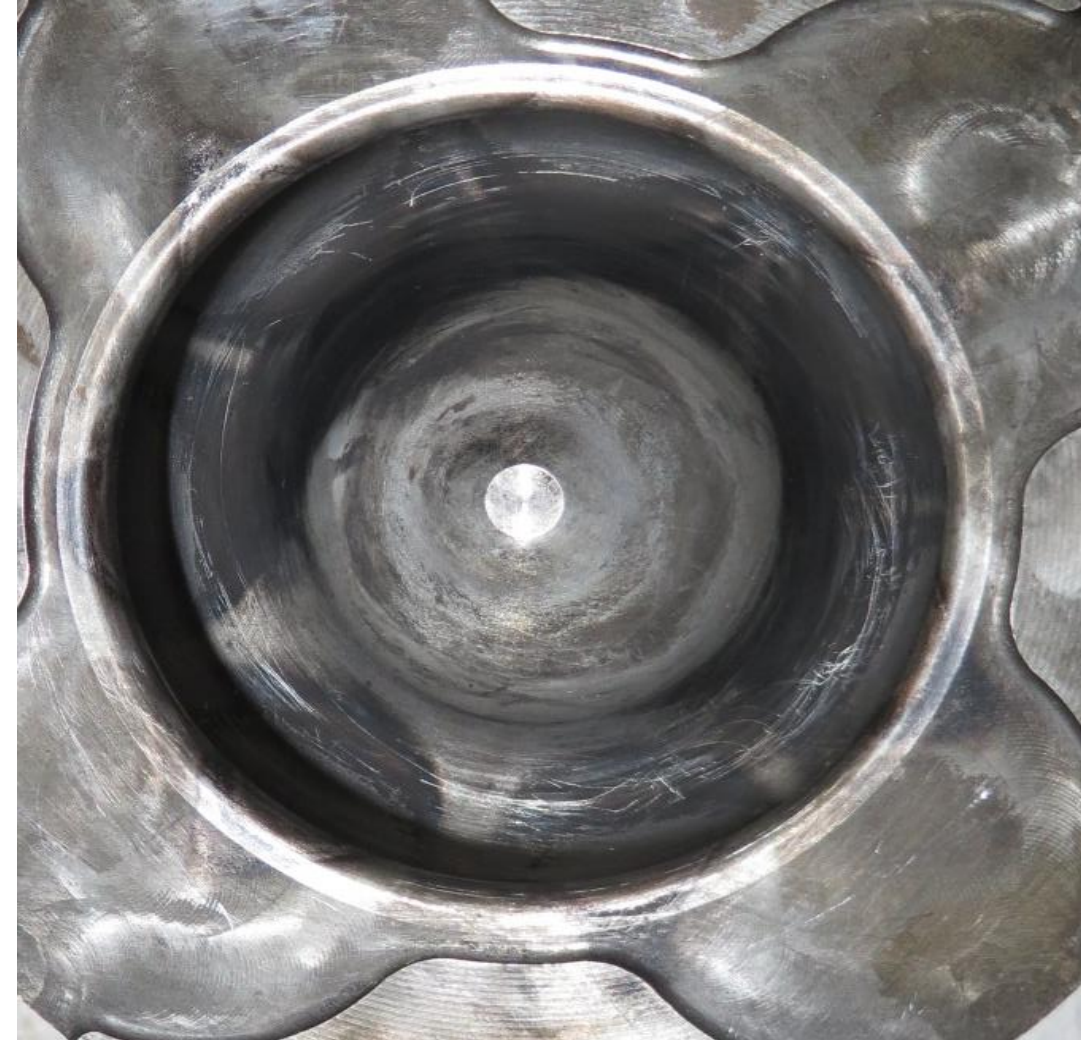
- One of the good pistons was cleaned to see the spray contact pattern.
- The pattern shows the timing is in a good zone as the spray zones are inside and up to lip of bowl area.
- Early combustion will show spray zones further out on top of piston.
- Piston failures from timing advance tend to fail with a longitudinal crack propagating across piston. There is no evidence of that type of failure here.

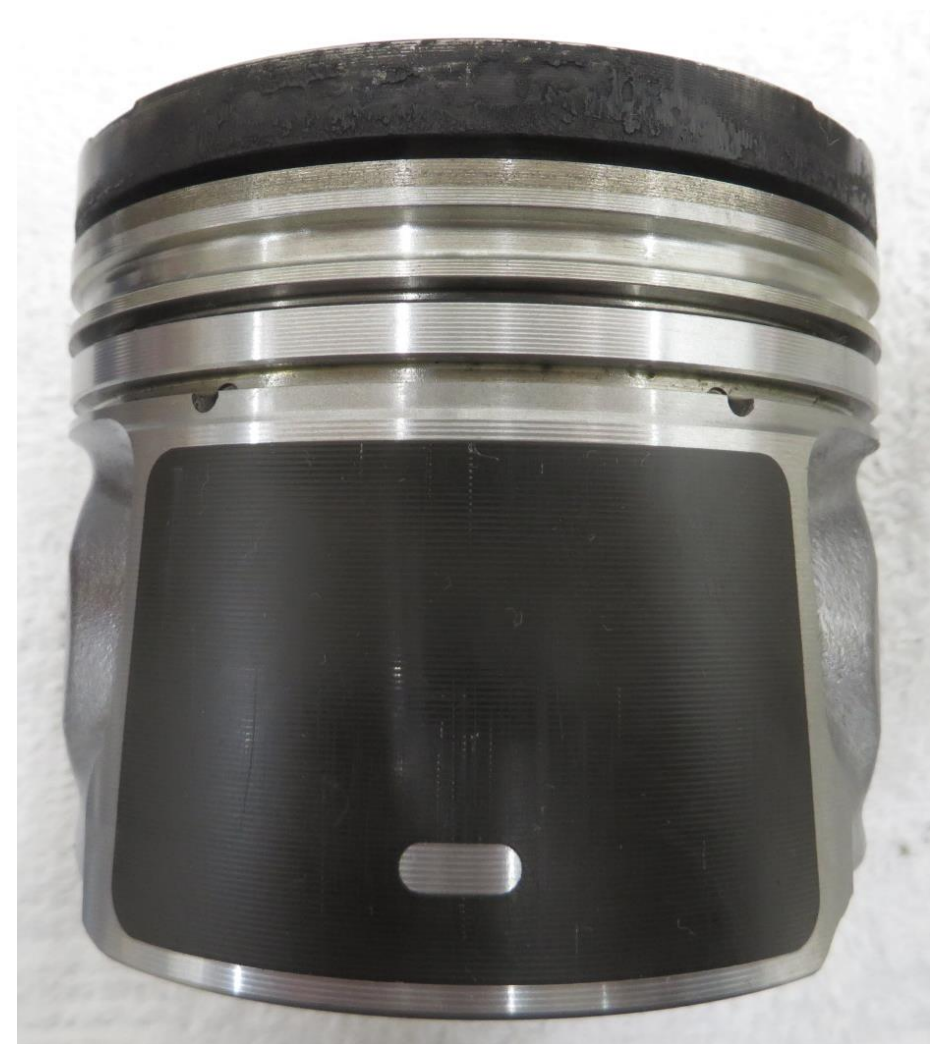
- Piston skirts show normal wear

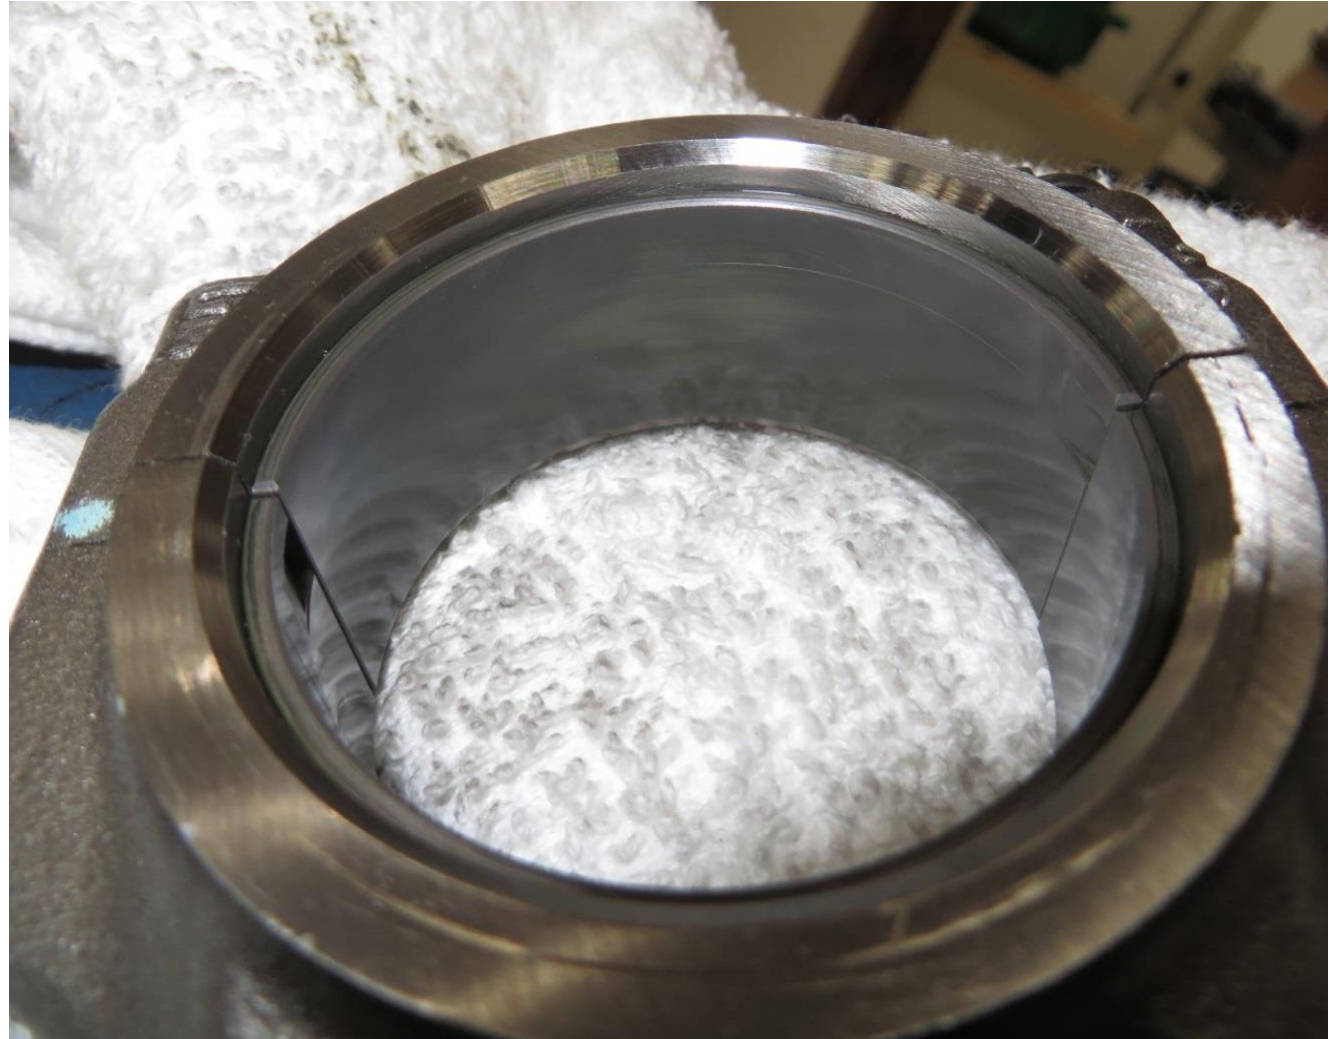
- Large end of the connecting rod bearings show normal signs of wear.

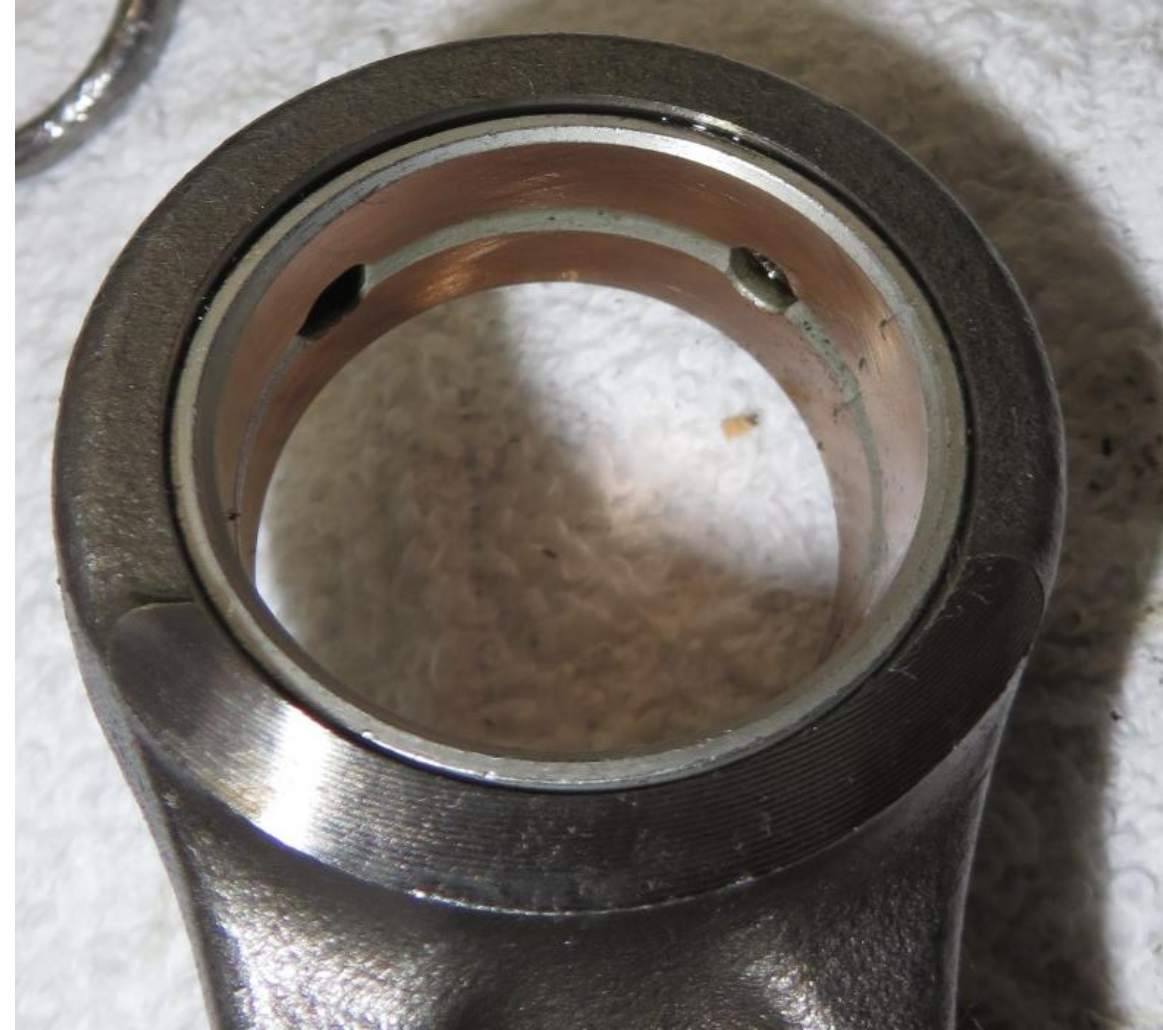
- The small end of the connecting rods are in good condition.
- The failed connecting rod did not have the small end attached and it was missing from engine.

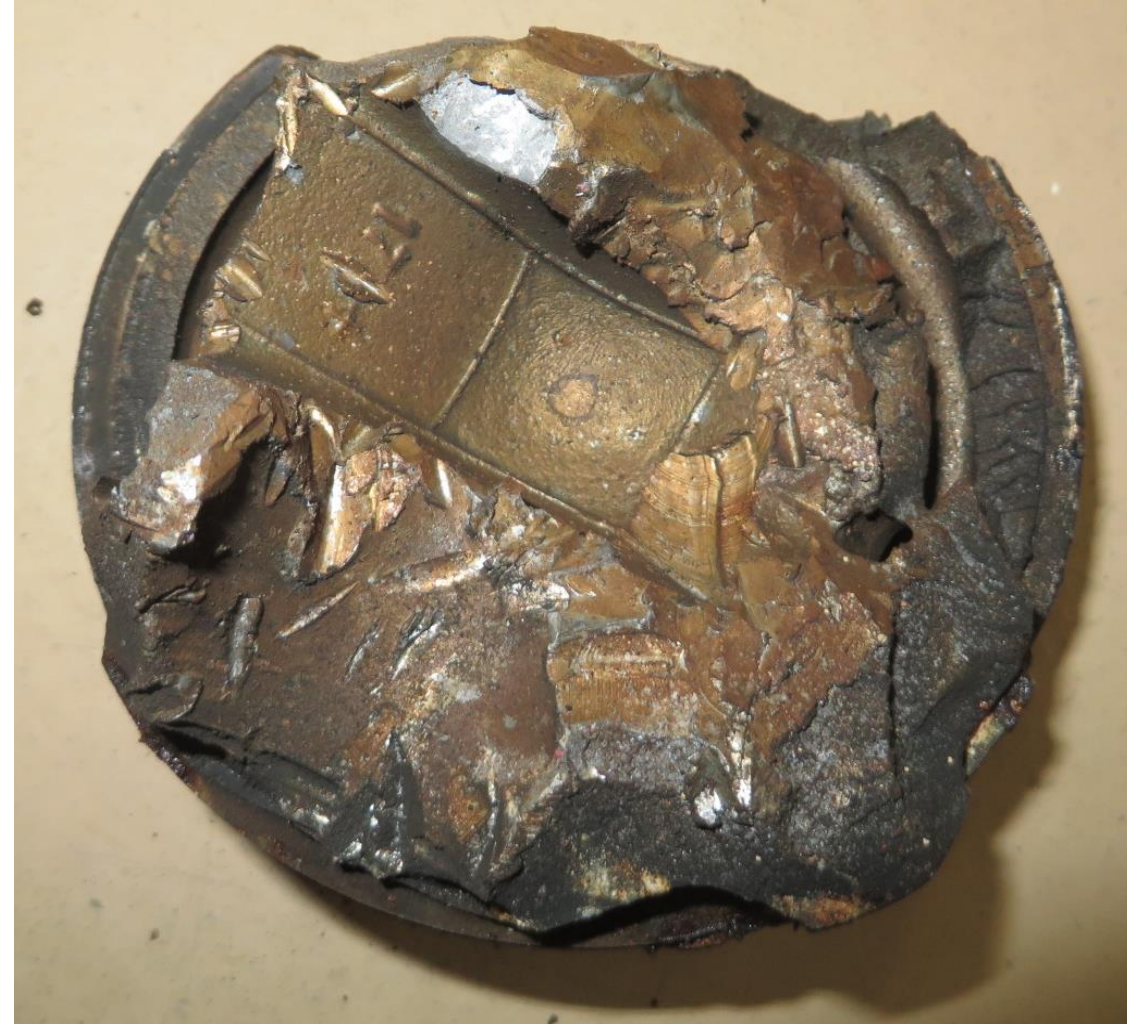
- The piston from the bottom view shows the severity of the damage.
- It appears the failure occurred in the wrist pin to piston connection.

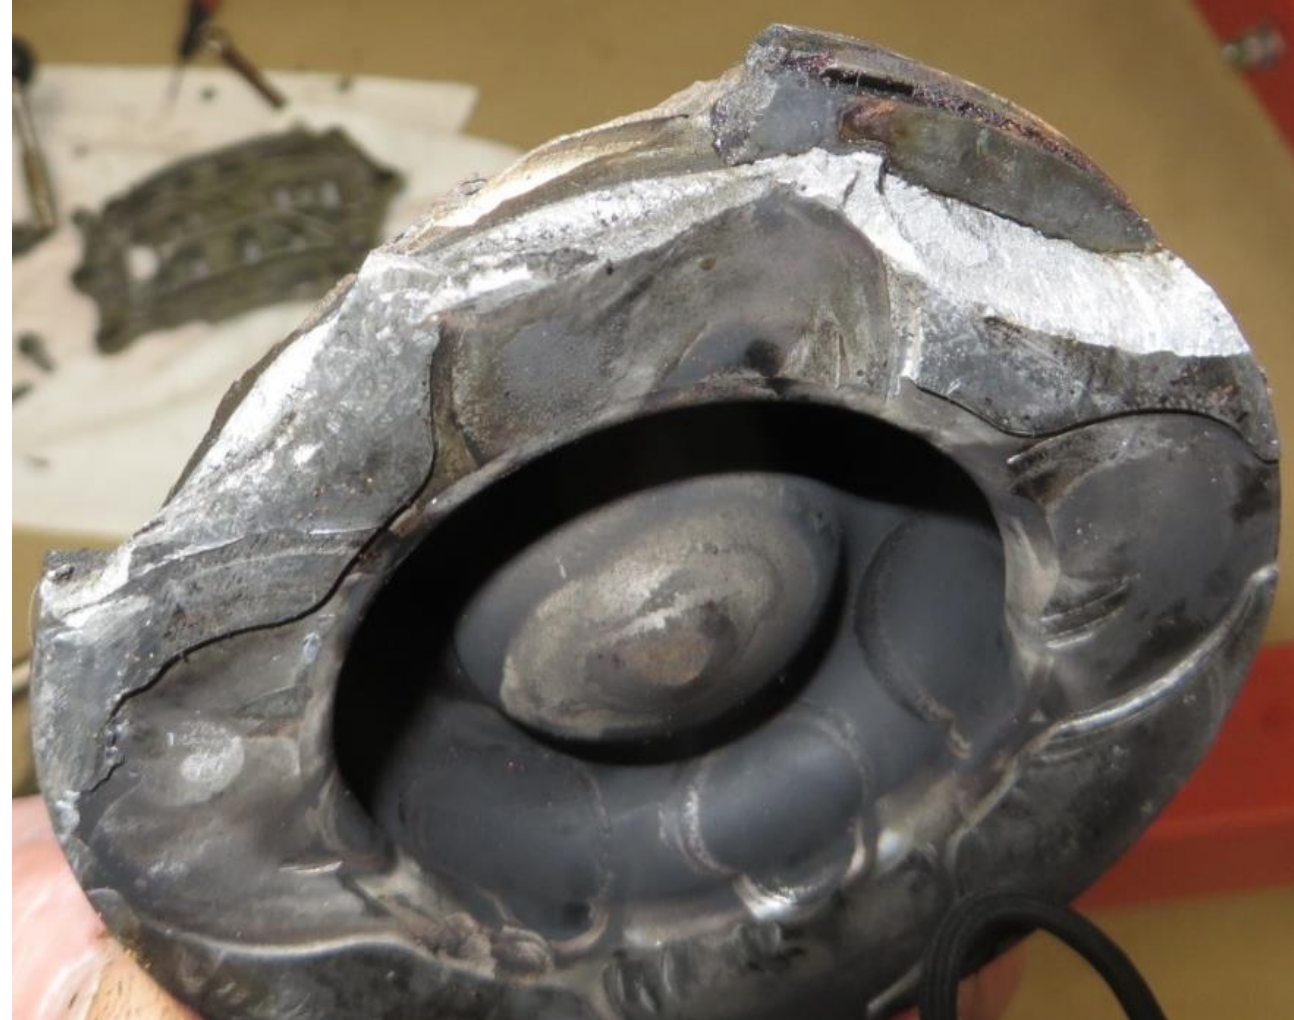
- After removing the piston from cylinder bore, the little fractures fell off.
- This also shows the injector spray pattern well.

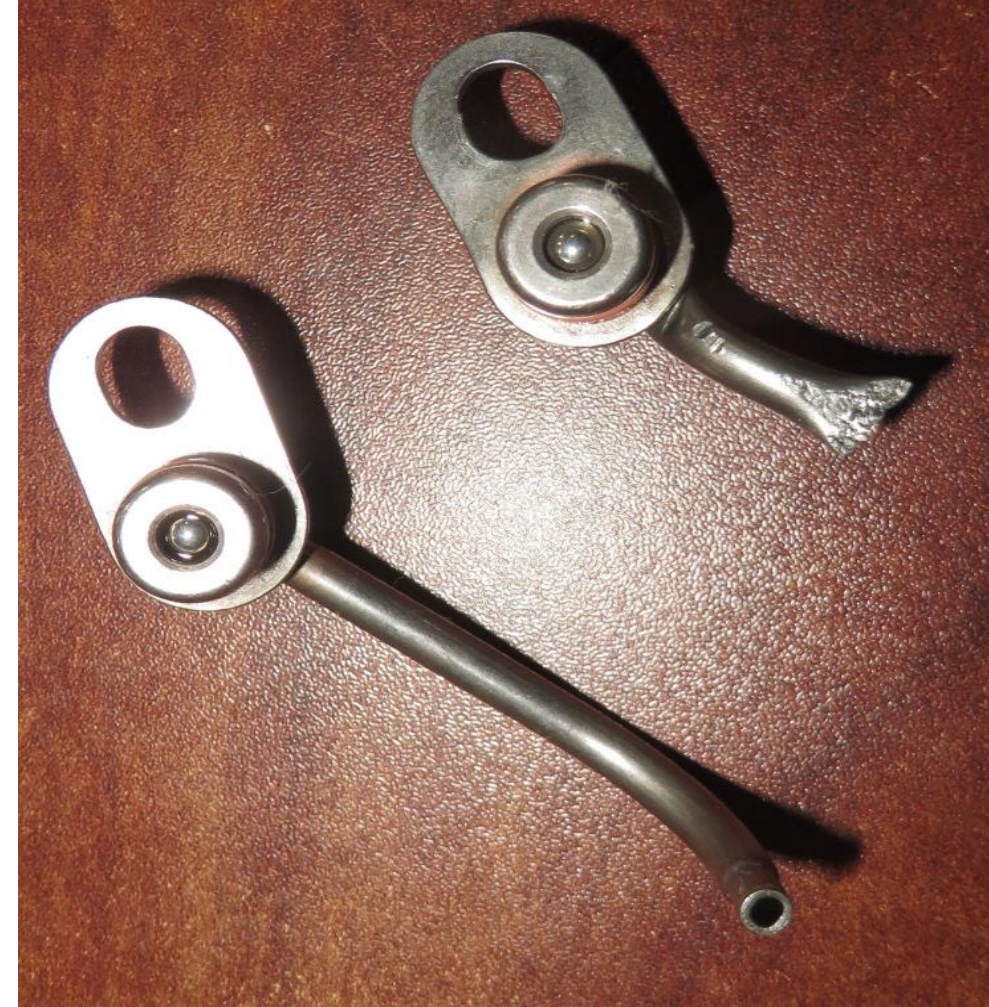
- The oil jets spray into a hole in underside of piston to supply oil cooling internally. This oil also dribbles down through a weep hole to lubricate the small end of connecting rod.
- The oil jets have a ball valve to stop oil flow at low pressure.
- Pictured are the #2 cylinder and #4 failed cylinder.

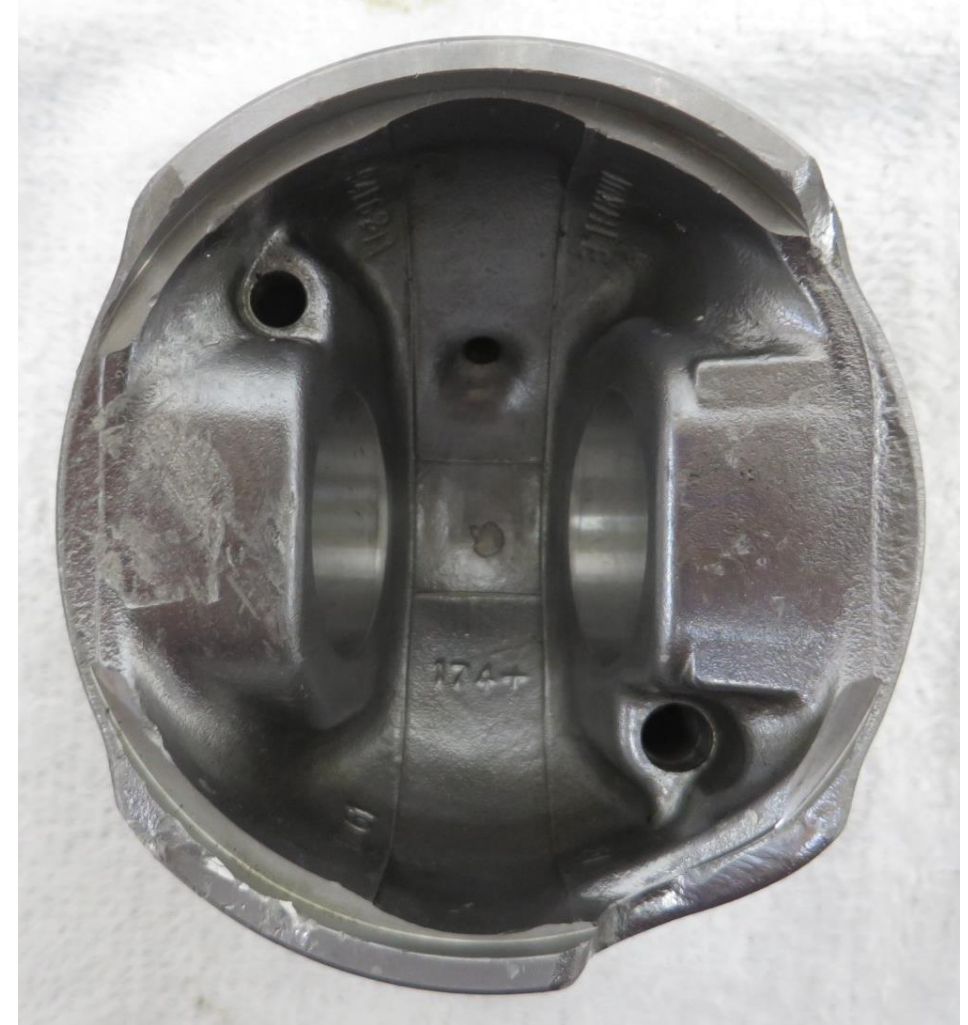
- See the larger holes for oil jet spray (in/out).
- The small hole near center of piston is where oil dribbles out to lubricate the small end of connecting rod.
- This is the underside of #3 piston.

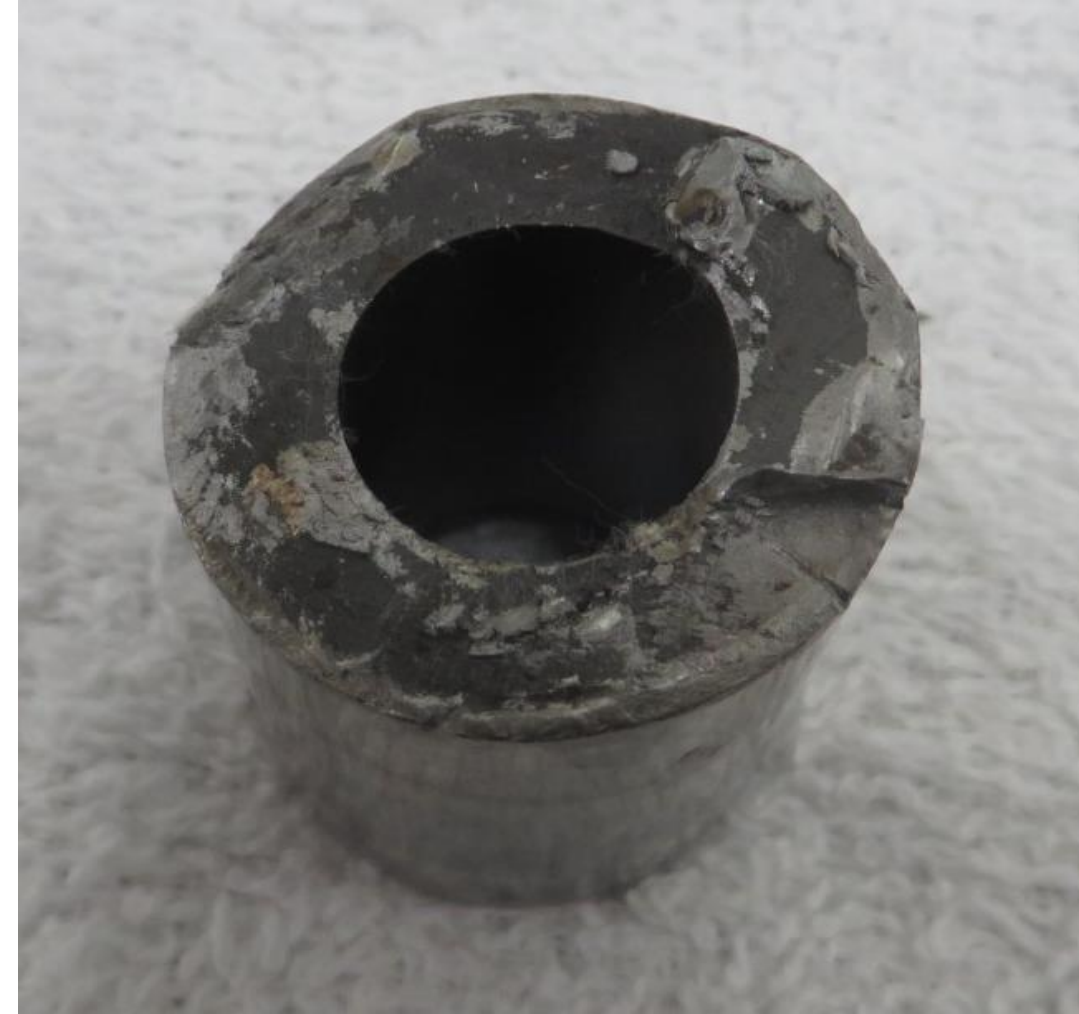
- The wrist pin fracture is concerning. It shows signs of fatigue failure (lip in fracture zone on right side of picture) and then it reached a point where the pin split in two, note the clean fracture on most of the surface area.
- The galling on the finished surface is also indicative of some material issues.

- There was a quality issue on the wrist pin due to poor heat treatment when the part was manufactured. The bad heat-treat leads to a weak wrist pin and eventual failure on a stock or tuned engine.
- We are sending the failed wrist pin and a few good ones for metallurgical analysis for confirmatory testing.

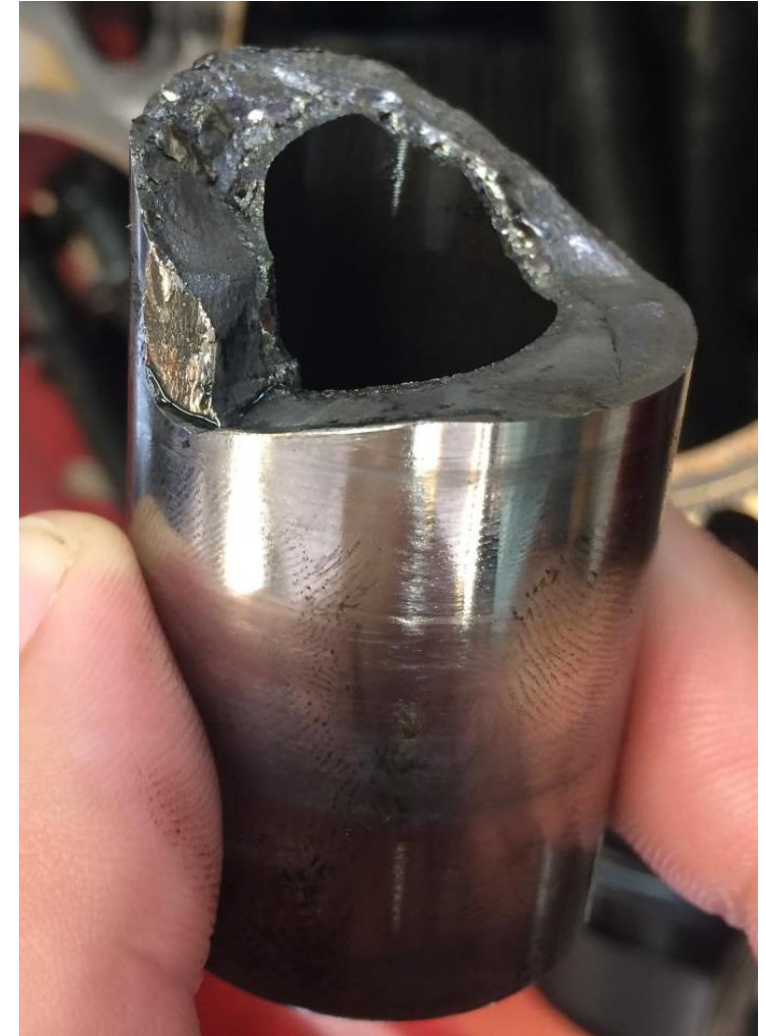
- This stock engine also had a failure of the wrist pin.
- Similar dent in center of pin that initiates a fatigue failure.
- The pin failed before it cracked the piston.

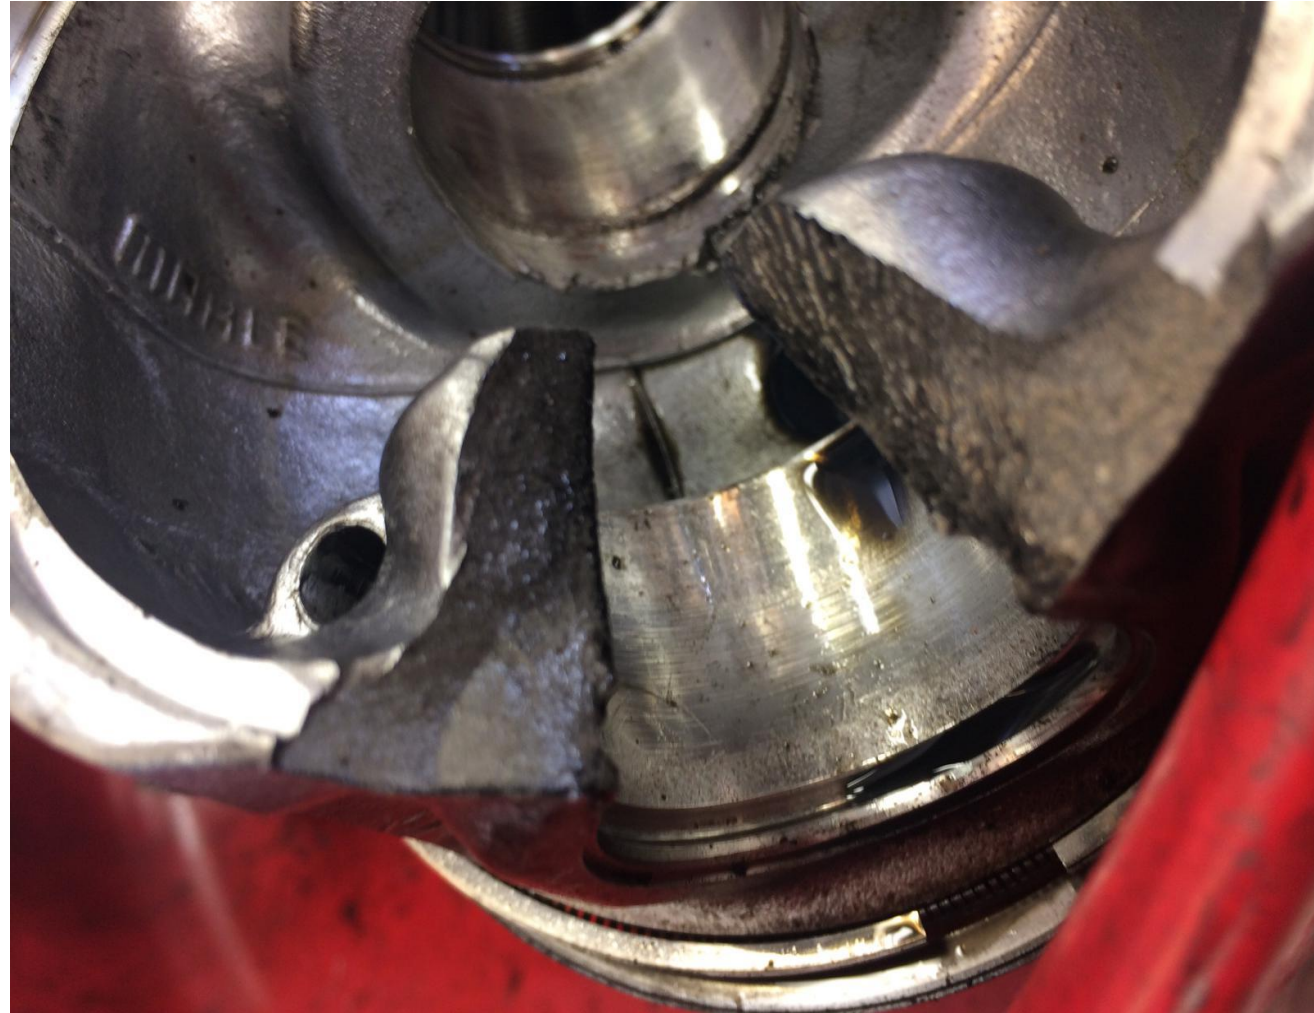
- Only one side of the piston was blown out.
- If the engine was run a bit longer the failure would have propagated fully.

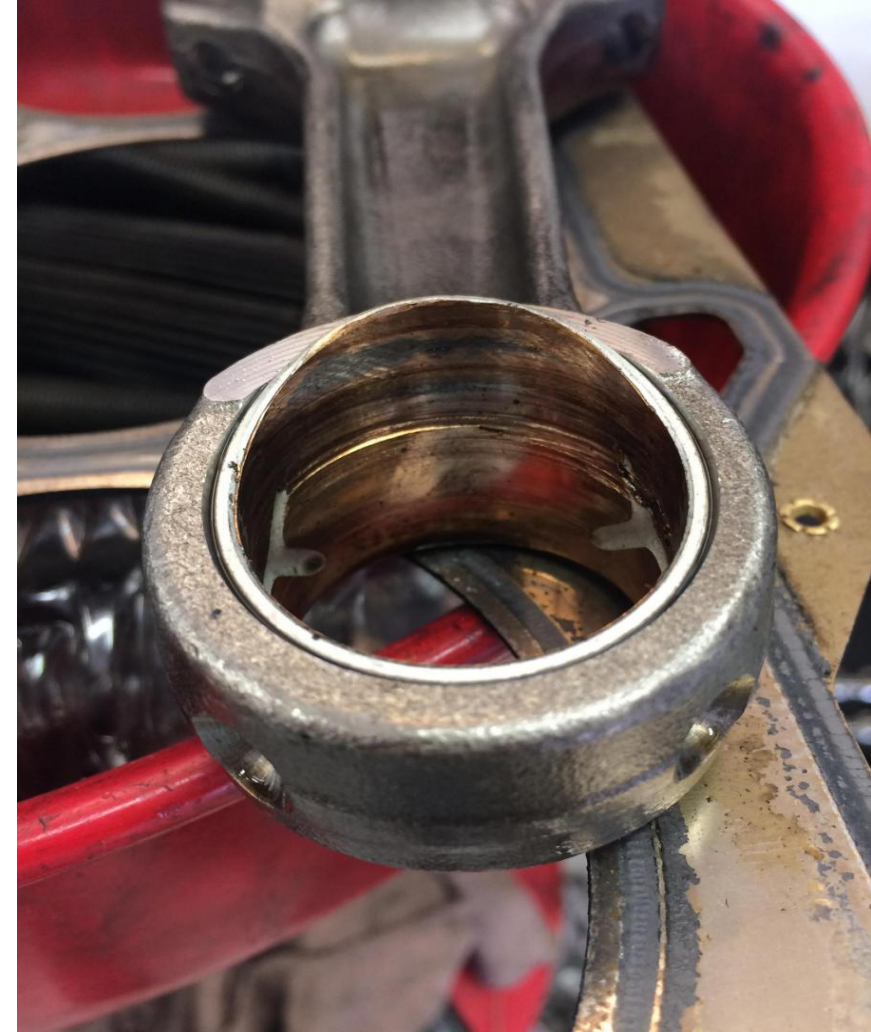
- Note the groove cut into bushing. It lines up with the wrist pin fracture point.
