NUMBER: 23-029-18

DATE: June 27, 2018

Hood Vibrates, Shakes or Flutters While Driving at Highway Speeds

2019 (DT) RAM 1500 Pickup

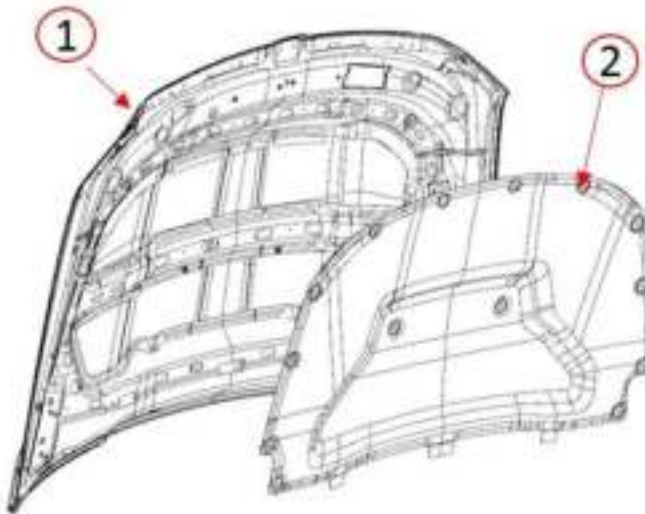
Fig. 2
Hood Silencer Pad

- 1 - Hood
2 - Hood Silencer Pad

3. Remove the Hood Silencer pad (Fig. 2) .

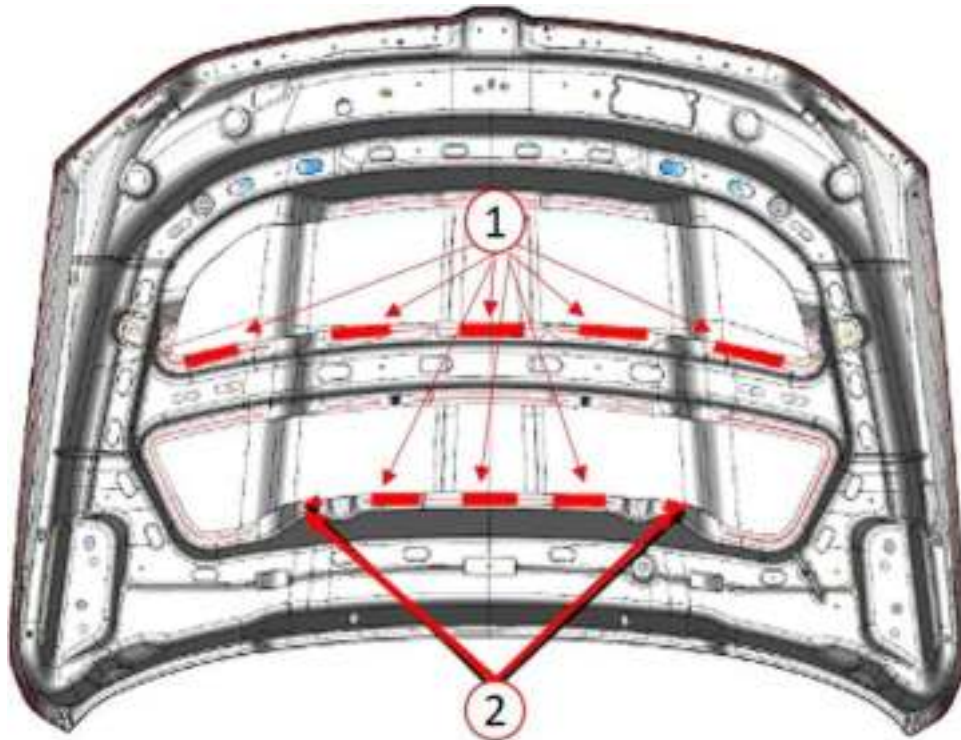
Fig. 4
Urethane Application Areas

- 1 - Apply Urethane in These Areas
- 2 - This Area is Less Than Two Inches – Fill Completely with Urethane in These Two Locations

6. Apply a 5 mm (0.2 in) diameter windshield urethane (MOPAR #04187367AB) bead 50 mm (2.0 in) in length (Fig. 4) at these locations in (Fig. 5) .

7. Once applied, verify that the urethane is bonded to both the hood inner and outer surfaces.

NOTE: To prevent hood indentations, do not apply pressure on the outer hood to wet out or try and bond, only the void should be filled between the inner hood and support beams.
