P203E AND P203F ADDITIONAL DIAGNOSTIC INFORMATION

NUMBER: 18-034-21

GROUP: 18 - Vehicle Performance

DATE: April 2, 2021

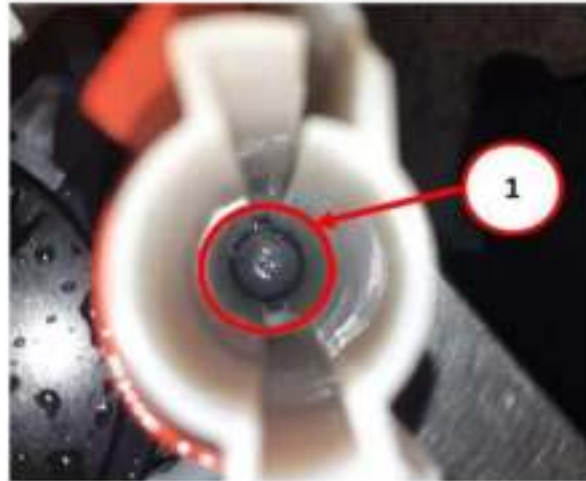
Fig. 1
DEF Pump Assembly

Another cause of P203E and P203F is residual ice in the DEF tank. Once ambient temperatures reach approximately 12°F (-11°C), the DEF fluid in the tank will freeze. The P203E diagnostic will not run if the DEF tank, and ambient temperatures stay below 39°F (4°C). However, as the ambient temperature warms up, and the tank begins to thaw, the DEF tank may not be completely thawed by the time the P203E DTC enabling criteria are met. If there is a residual layer of ice in the tank, the ice will cause the "no echo" condition setting P203E. Vehicles are especially susceptible to having residual ice in the tank, in areas where there is a large swing in temperatures (from extreme cold to warm), in a short period of time. Additionally, if ice is covering the sensor (Fig. 1) when the temperatures are too cold to run the P203E monitor, it could lead to P203F. Even if there is sufficient fluid level in the tank.

1 - Ice in Level Sensor Focus Tube.

To correct this scenario, the DEF tank must be fully thawed out. Allow the vehicle to sit in a heated shop or garage overnight to thaw. If necessary, remove the DEF pump to drain the fluid, and remove all residual ice. Take care when removing the DEF pump to avoid damage to the pump, and heater mat. Once all the ice has been removed or thawed, follow the **P203E Drive Cycle** below.

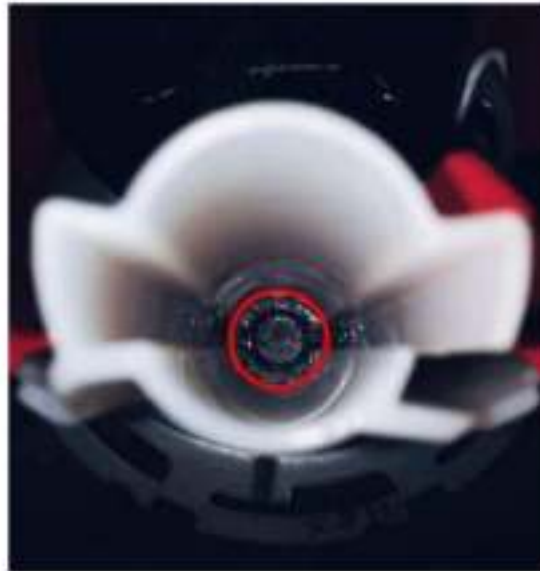
Another cause of P203E and P203F is the DEF level sensor being covered in a layer of DEF crystals, or ice (Fig. 2). Vehicles that are in extreme cold for long periods of time can start to have a buildup of DEF crystals on the bottom of the tank. When DEF tanks are completely frozen for long periods of time, evaporation will start to occur. This evaporation of the ice will leave DEF crystallization.

Fig. 2
DEF Crystallization Buildup In Level Sensor Focus Tube

NOTE: Do NOT clean DEF system components using regular tap water. The mineral content in tap water can cause issues with the system. Only use fresh DEF fluid, or warm, distilled water to clean crystallization from the DEF components.

Unless the DEF fluid shows signs of contamination, crystallization that has formed in the tank, and on the pump components can be cleaned without having to replace any parts. Flush the tank, and clean the pump components using fresh DEF, or warm distilled water. In some instances, it may be necessary to remove the DEF tank, and agitate the fluid by shaking the tank. Thoroughly drain the DEF or distilled water used to clean the crystallization, and add fresh DEF. If P203E was set, follow the **P203E Drive Cycle** below.
