NUMBER: 08-062-22 REV. A

GROUP: 08 - Electrical

UPD UFD UBD UED UBC UEC Radio Enhancements

This bulletin involves inspecting the software level and updating the software if needed. The software will be updated to 141.01.12.00.

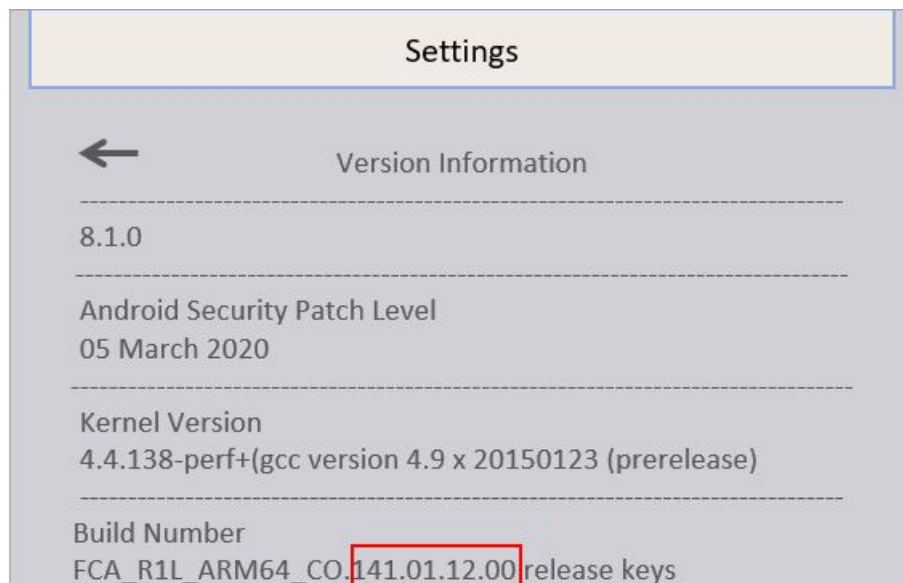
Fig. 1
Radio Software Level Screen

1. On the radio display screen go into "Vehicle Settings".
2. Select "System Information".
3. Select "Version Information".
4. Under the "Build Number", radio software version is listed. For example, the software version here is 141.01.12.00 (Fig. 1) .

- YES>>> The software version is below 141.01.12.00. Proceed to [Step 1](#) of the repair procedure below.
- NO>>> If the software version is at or above 141.01.12.00, the radio is already at updated software. This bulletin has been completed, Use inspection LOP (18-60-02-9R) to close the active RSU.
