THE NUMBER ONE DODGE/CUMMINS TURBO DIESEL RESOURCE

ISSUE 82

FROM THE SHOP FLOOR

TAP-PY TAP-PY NOISE

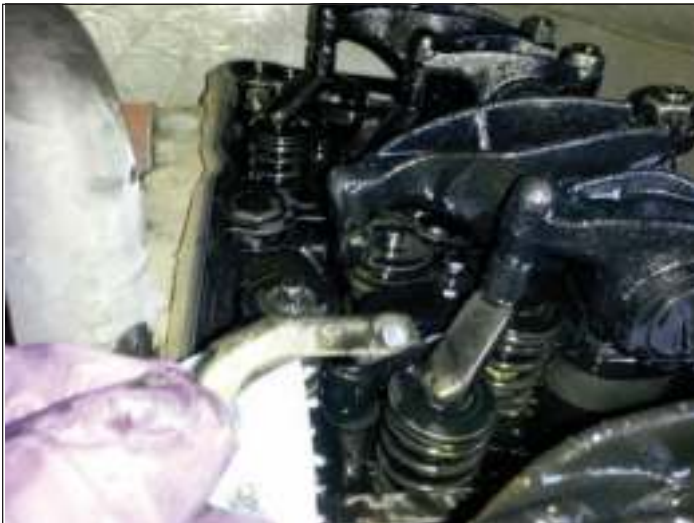
After checking the fluid levels, the engine was started momentarily. It certainly tapped, and it had a dead cylinder miss. So off comes the valve cover.

What was found? Cylinder number five's rocker bridge was missing. I found it down in the valley near the valves so it was moved into the photo. It must be in place for the push rod and rocker arm to depress the exhaust valves.

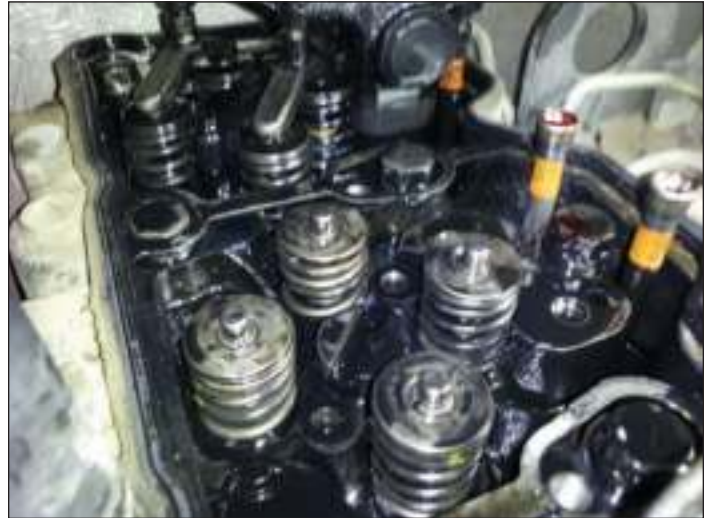
Looks like the crossover bridge is broken.

Now, how and why did the bridge break? Several potential causes: bent push rod(s); stuck, bent or broken valve(s); broken valve spring; etc., I used the barring tool to find top dead center (TDC) for this cylinder. [Other popular methods to rotate the crankshaft and observe valve operation include: a 22mm socket on the alternator (turns engine backwards) or a 18" pipe wrench turning a 15mm socket on one of the bolts holding the vibration damper.] While turning the engine over, if the engine stops moving find out why, or you will break more "stuff." To find TDC we need to know the firing order of an inline six cylinder: 1-5-3-6-2-4. It is also helpful to know the companion cylinders, which are 1/6; 2/5; 3/4. If cylinder number 1 is at TDC (valves closed) companion cylinder 6 will have valve overlap. The companion concept and also a tenet principle of the four cycle engine.

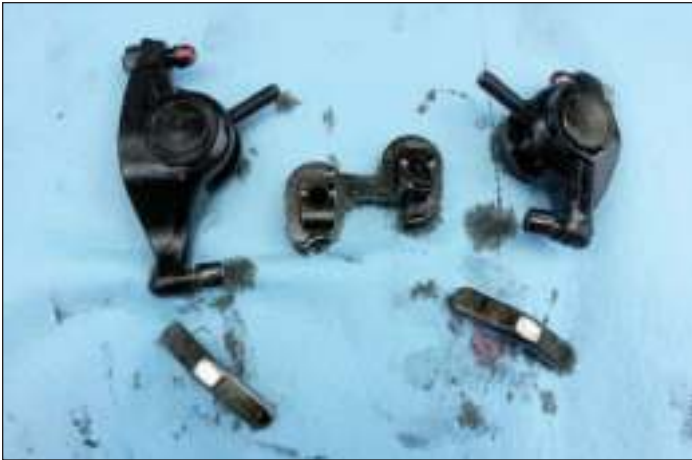
Compare the exhaust valve springs, do you see any differences? There is a problem. The spring on the right is broken and not able to hold the exhaust valve closed. Now let's repair the "tap."

The broken parts.

So why did the exhaust spring break? We may never know. The odometer showed in excess of 300,000 miles. The owner of the truck never recalls the valves being adjusted. All of the valves were adjusted after this spring was changed and many were quite loose. The scary thing is that other extensive damage can occur if a spring breaks—such as bent valve(s), damaged valve guide, cracked head/seat and piston/cylinder wall damage. It is difficult to be certain if a valve was bent, since the head was not removed. However, this truck's owner was willing to gamble, and won. That's the rest of the story for ole tap-py- tap-py.

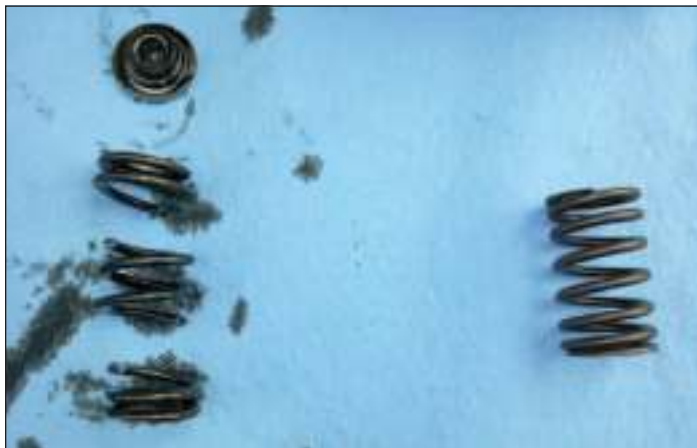
The valve spring retainer, broken valve spring and new spring on right.

Next loosen the stud nut on the compressor tool, remove the tool and also remove the broken valve spring.
