NUMBER: 18-021-15 REV. E

Flash: 3.0L Powertrain Diagnostic And System Enhancements

RAM 1500 Pickup

NOTE: This bulletin applies to vehicles equipped with a 3.0L Diesel Engine (Sales Code EXF).

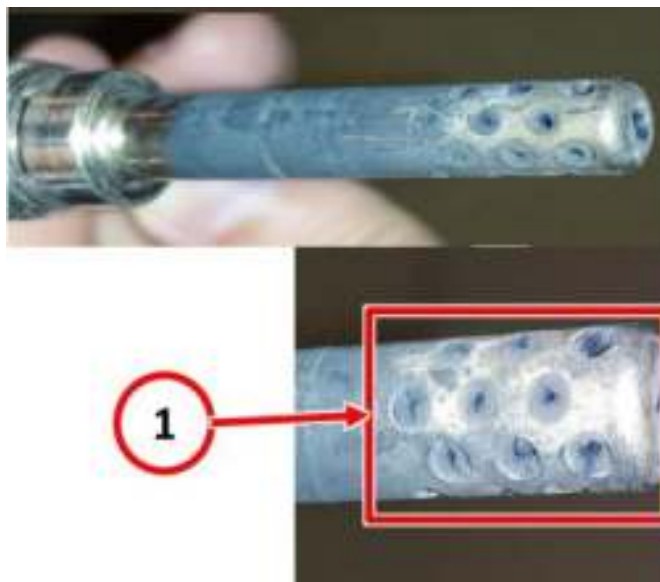
Fig. 1 EGT Sensor Bank 1 Sensor 1

1 - Excessive soot blocking sensor ports

-
14. Was excessive soot found on the sensor?
 - a. Yes>>> Proceed to [Step #15](#).
 - b. No>>> Proceed to [Step #16](#).
 15. Using shop air set to a maximum of 80 psi, clean all excessive soot from the sensor probe.
 16. Using a suitable multi-meter with appropriate test probes, test the resistance between the sensor connector terminals 1 and 2. With the sensor at room temperature, 65-75 °F (18-25 °C), the resistance should measure between 200 and 240 ohms.
