NUMBER: 18-087-16 REV. A

Engine Oil Viscosity Upgrade And Flash Enhancements

2016	(WK)	Jeep Grand Cherokee
2016	(DS)	Ram 1500 Pickup

**NOTE: This bulletin applies to vehicles equipped with a 3.0L Diesel Engine (Sales
Code EXF or **EXN**).**

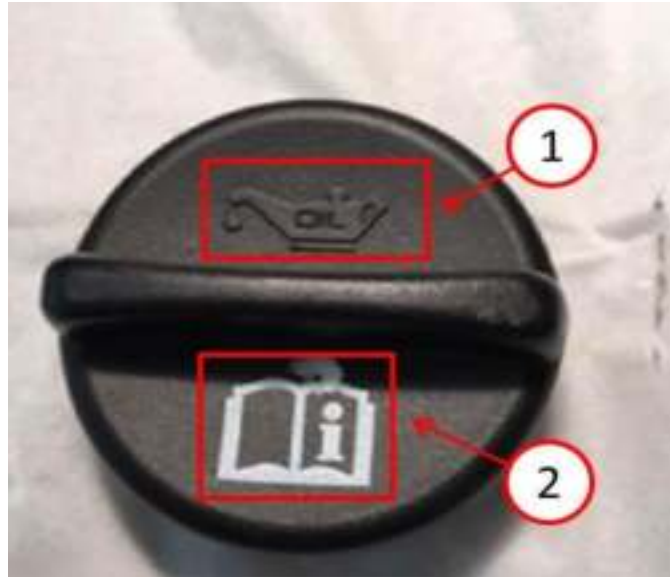
Fig. 1 Cap Before Sticker Applied

1 - Do Not Cover This Embossed International Oil Symbol

2 - Cover This Old Oil Info Symbol With The New "5W40" Label

6. Remove oil fill cap.
7. Clean top of oil fill cap with Isopropyl alcohol or equivalent and apply engine oil viscosity rating sticker as shown in (Fig. 1).

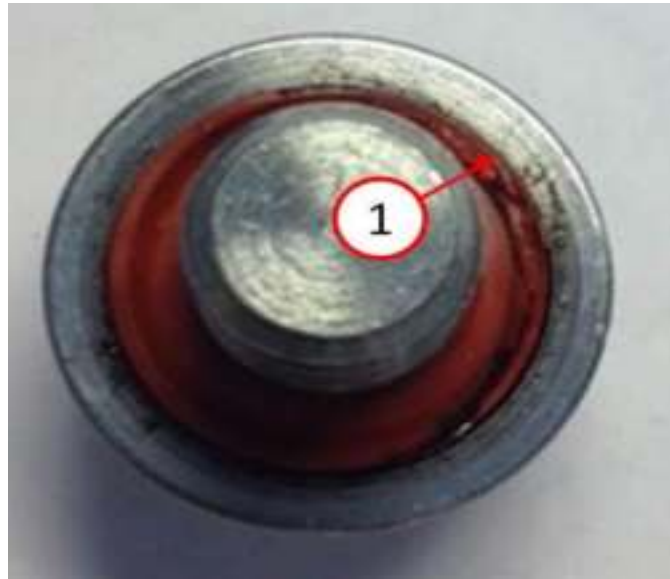
Fig. 2 Damaged Rubber Seal

1 - Oil Drain Plug Gasket Seal Crushed

8. Remove the oil drain plug and allow oil to drain for at least 5 minutes or until it stops dripping.
9. Inspect the oil drain plug and gasket for damages ([Fig. 2](#)). Replace if necessary.

-
10. Reinstall the oil drain plug. Tighten to 45 N·m (33 ft. Lbs.).
 11. Add 5W-40 synthetic engine oil to the engine. Use 10 quarts for (DS) Ram trucks and 8 quarts for (WK) Jeep Grand Cherokee. Take care not to spill oil on engine.

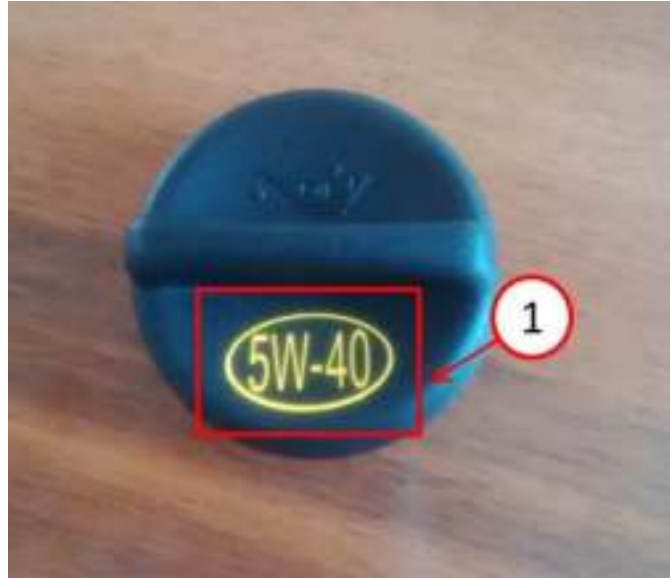
Fig. 3 Cap After Sticker Applied

1 - "5W-40" Sticker Affixed To Oil Filler Cap

12. Reinstall the oil fill cap with the new 5W-40 sticker firmly attached ([Fig. 3](#)).
