NUMBER: 23-015-18

GROUP: 23 - Body

Headlamp Condensation and Fogging

This bulletin involves installing updated vent caps on the headlamp assembly.

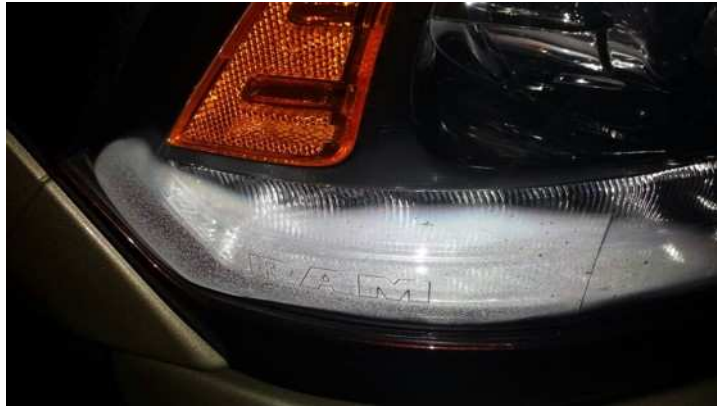
Fig. 1

NOTE: If the condensation/fogging has begun to clear from the lamp lenses after 20 minutes of lamp operation, the headlamp assembly seal is not defective and the headlamp assembly does not require replacement. (Fig. 1) and (Fig. 2) are examples of good and faulty headlamp assemblies.

Normal Headlamp Clearing - Install Updated Vent Caps

- YES>>> Replace the vent caps. Proceed to [Step 1](#) of the Repair Procedure.
- NO>>> Proceed to [Step 3](#).

NOTE: When installing the vent caps on one side only, the vent caps must be installed on the other assembly also.

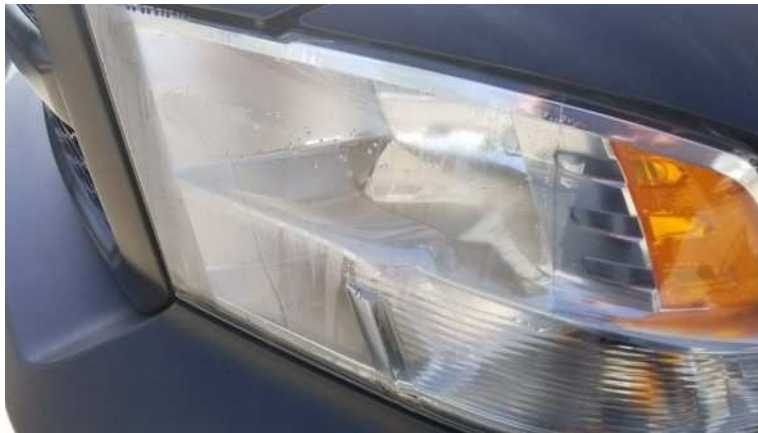
Fig. 2

Heavy Condensation With No Clearing - Replace Headlamp Assembly

3. If one headlamp assembly cleared and the other still has heavy condensation in it, only install the vent caps on the assembly that cleared up. Proceed to [Step 1](#) of the Repair Procedure. **The headlamp that still has condensation with no clearing in it will need to be replaced. Use normal Service Information and normal warranty process and procedures.**

NOTE: Replacement headlamp assemblies will already have the updated vent caps installed.

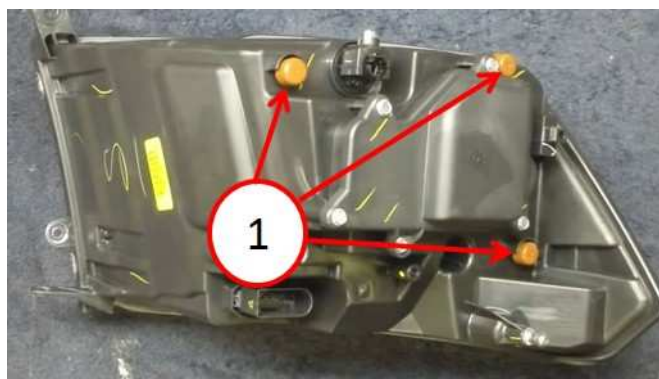
Fig. 3
Location Of Vent Caps

1 - Three Vent Caps

1. Remove the headlamp assemblies. Refer to the detailed service procedures available in DealerCONNECT> TechCONNECT> 8L - Lamps and Lighting / Lamps/Lighting - Exterior / Unit, Front Lamp/Removal.
2. Remove and discard the old vent caps by pulling them rearward from the headlamp assembly ([Fig. 3](#)) .

3. Install the new (brown) vent caps by pushing them on the bosses of the headlamp assembly.
4. Install the headlamp assemblies. Refer to the detailed service procedures available in DealerCONNECT> TechCONNECT>08 - Electrical/8L - Lamps and Lighting/Lamps/Lighting - Exterior/Unit, Front Lamp/Installation.
