Revised (2) April 2019

Dealer Service Instructions for:

## Safety Recall V06 / NHTSA 19V-021 Drag Link

The drag link on about 795,000 of the above vehicles may have been built with an outboard steering linkage jam nut that could loosen allowing one end of the drag link to separate from the adjuster sleeve. A drag link separation can result in a loss of directional steering control, which can cause a vehicle crash without prior warning.

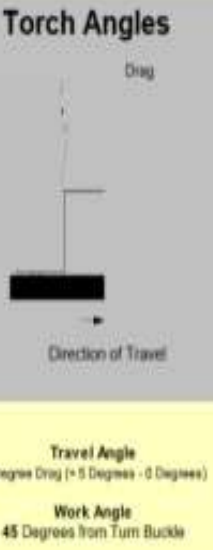
Figure 8 – Weld Procedure Values

6. Following the weld procedure values in chart below (Figure 8).

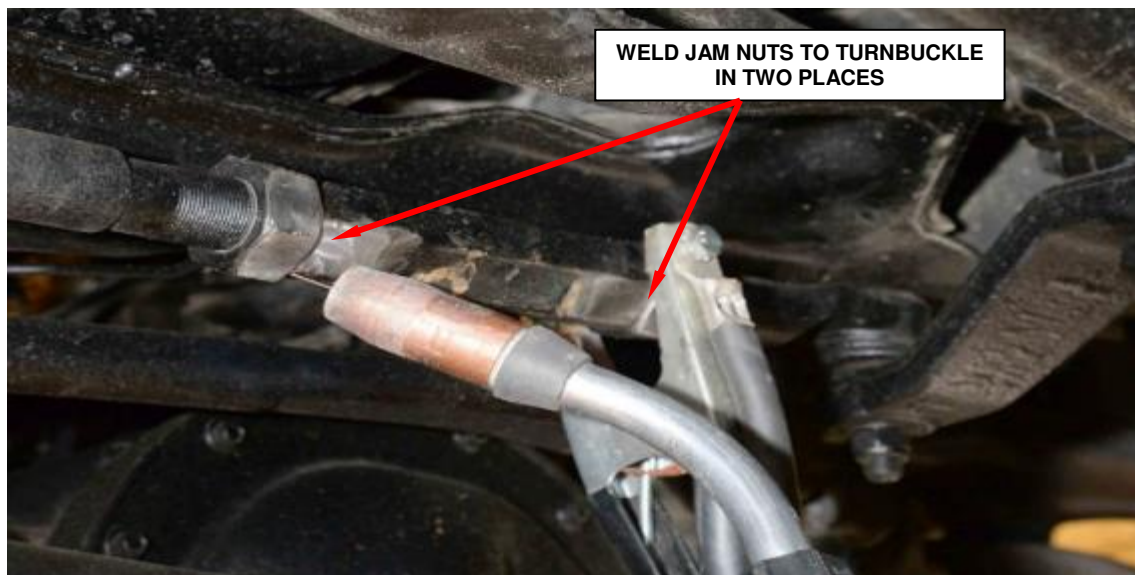
Figure 9 – Weld Both Jam Nuts to the Turnbuckle

7. Using a Lincoln Powerwave 350 Flux Cored Arc Weld (MIG) or equivalent GMAW (MIG) welding machine (140-150 amps), apply a **17mm long weld the length of one turnbuckle flat on each jam nut** (Figure 9).

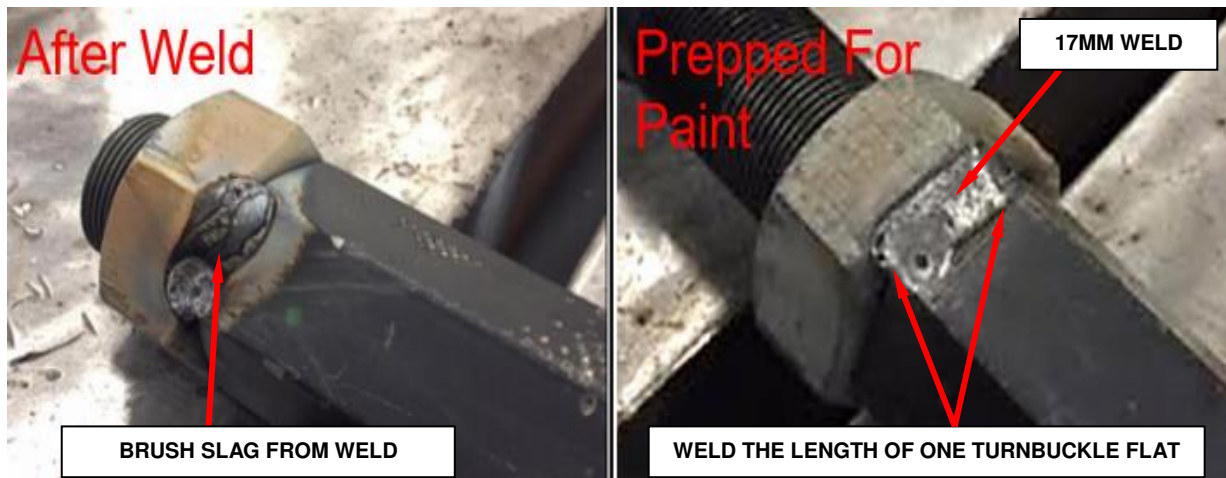
**Figure 10 – Prepare areas for Paint**

8. Wire brush the slag from the surface of the welds (Figure 10).
9. Allow to cool to room temperature.

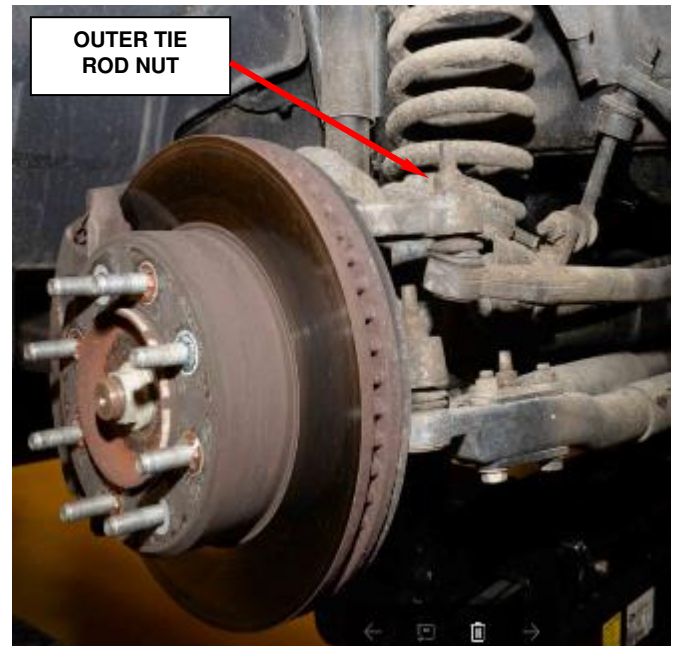
**Figure 11 – Outer Tie Rod**

1. Raise and support the vehicle.
2. Remove the right front tire and wheel assembly.
3. Remove and **DISCARD** the outer drag link to tie rod nut (Figure 11).
4. Remove the outer drag link tie rod from the knuckle using C-3894-A (puller shown in Figure 12).
