THE NUMBER ONE DODGE/CUMMINS TURBO DIESEL RESOURCE

ISSUE 82

FROM THE SHOP FLOOR

TAP-PY TAP-PY NOISE

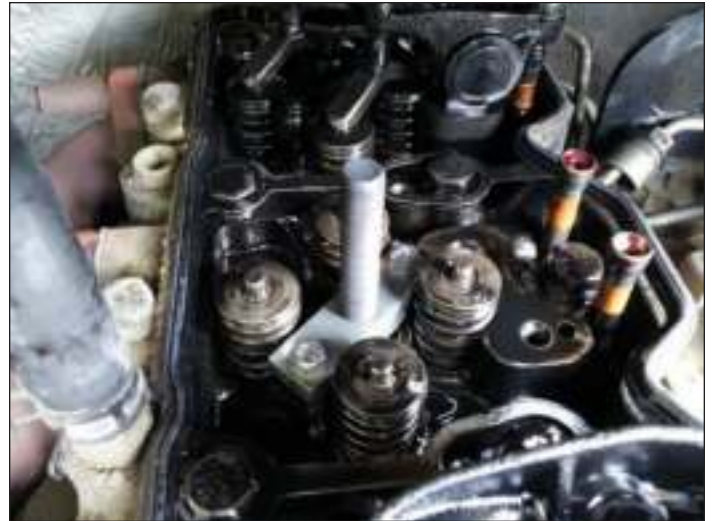
The injector hold down and both fasteners are removed so the base of the spring compressor can be installed. Since the injector is removed, it's simple to peer down into the cylinder. I told you that the piston is at TDC.

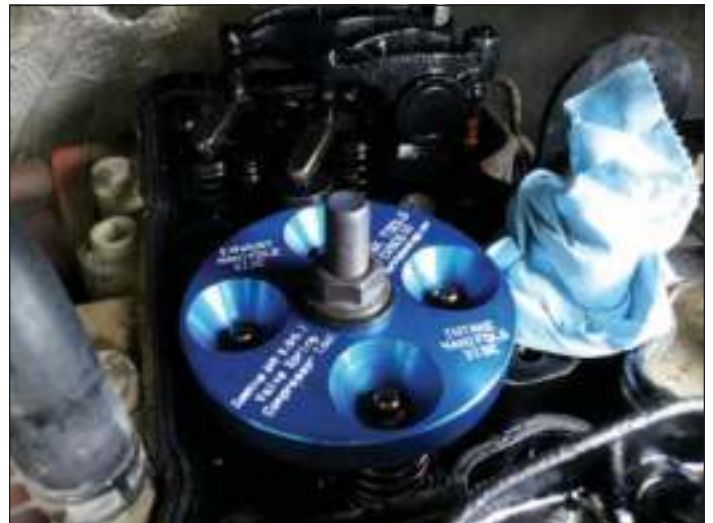
The push rods were checked and re-installed. Notice the rag covering the push rod openings? Why tempt fate with an errant valve stem retainer? The tool will smoothly depress the valve springs and stays centered on the springs. Keep a pencil magnet and a magnetic parts bowl handy to hold your parts.

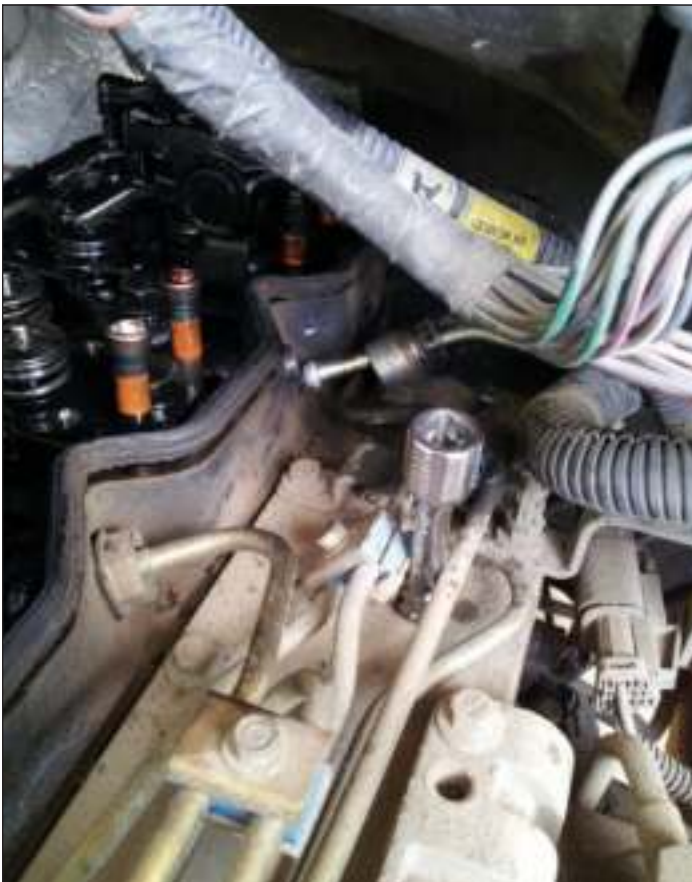
The tool requires the fuel injector to be removed. Notice the 3/8" drive extension holding the loosened fuel line away from the head so the connector tube can be disengaged from the injector inlet.

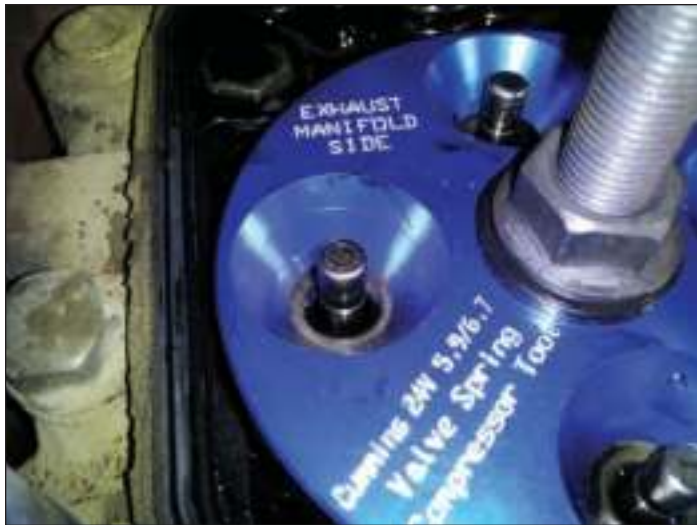
Close up of the compressed springs without the valve stem retainers.

Next loosen the stud nut on the compressor tool, remove the tool and also remove the broken valve spring.
