Dealer Service Instructions for:

Safety Recall V06 / NHTSA 19V-021

Drag Link

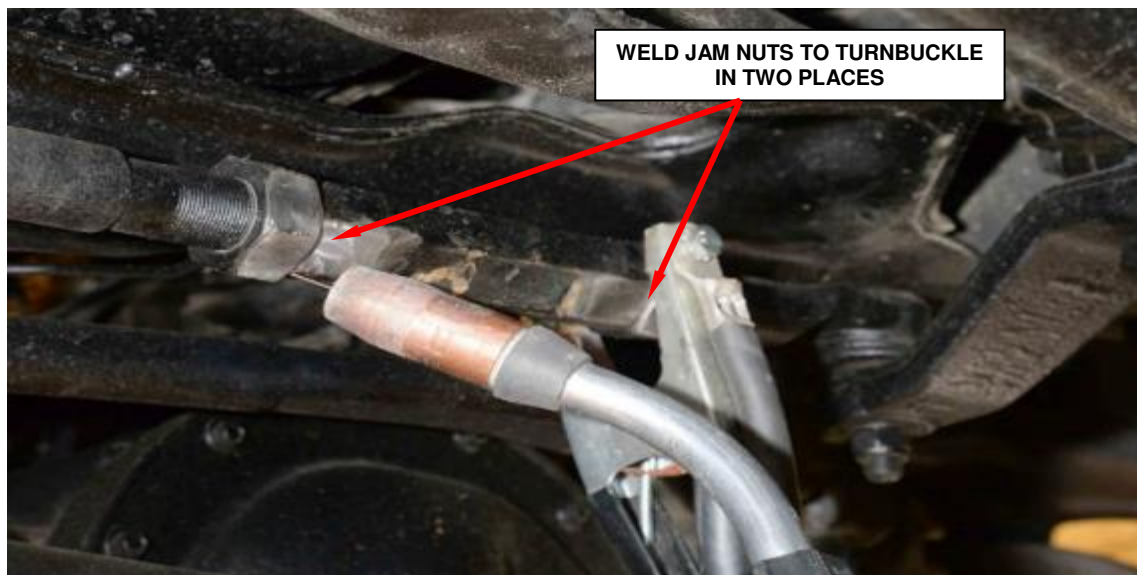
Figure 9 – Weld Both Jam Nuts to the Turnbuckle

7. Using a Lincoln Powerwave 350 Flux Cored Arc Weld (MIG) **or equivalent GMAW (MIG) welding machine (140-150 amps)**, apply a **17mm long weld the length of one turnbuckle flat on each jam nut** (Figure 9).

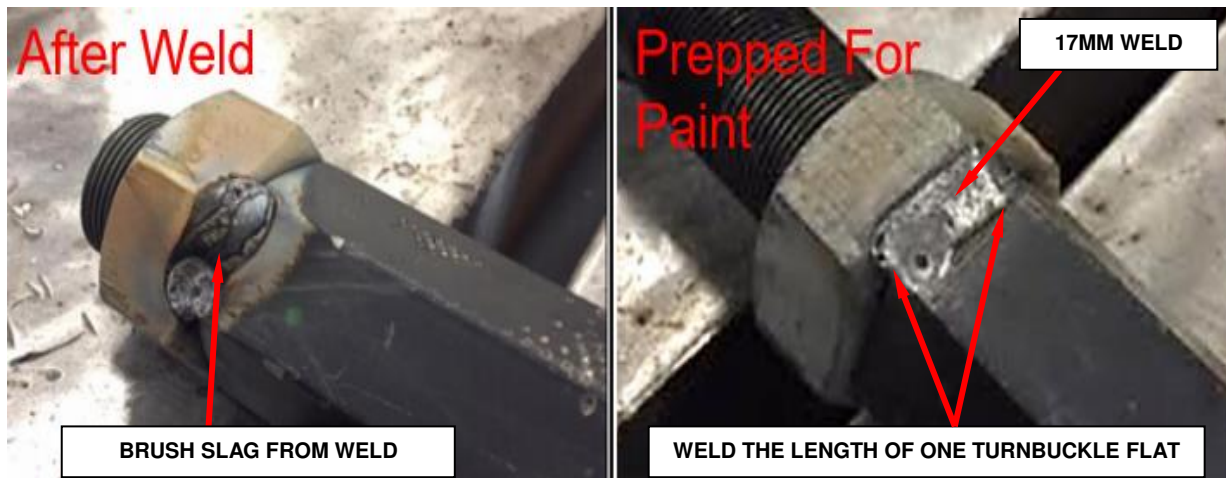
Figure 10 – Prepare areas for Paint

8. Wire brush the slag from the surface of the welds (Figure 10).
9. Allow to cool to room temperature.

NOTE: Each jam nut must hold a breakaway torque of 105 N·m (77 ft. lbs.).

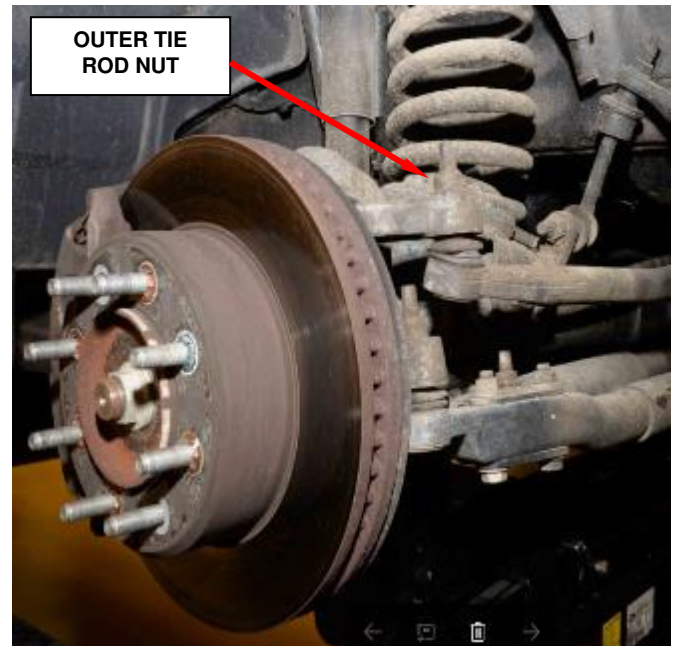
**Figure 11 – Outer Tie Rod**

1. Raise and support the vehicle.
2. Remove the right front tire and wheel assembly.
3. Remove and **DISCARD** the outer drag link to tie rod nut (Figure 11).
4. Remove the outer drag link tie rod from the knuckle using C-3894-A (puller shown in Figure 12).
