Dealer Service Instructions for:

Safety Recall V06 / NHTSA 19V-021 Drag Link

The drag link on about 795,000 of the above vehicles may have been built with an outboard steering linkage jam nut that could loosen allowing one end of the drag link to separate from the adjuster sleeve. A drag link separation can result in a loss of directional steering control, which can cause a vehicle crash without prior warning.

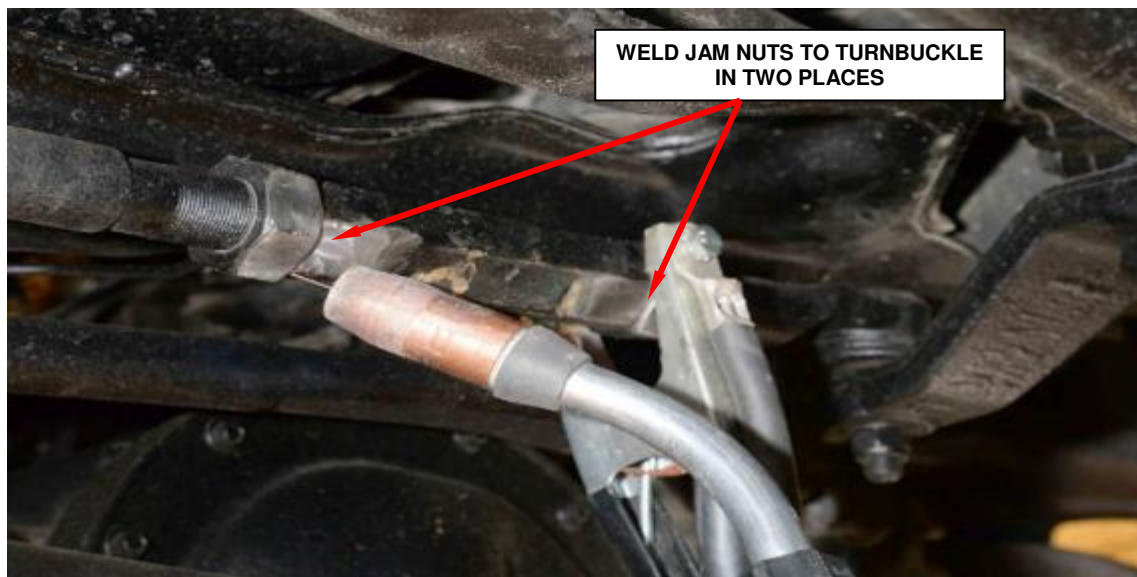
Figure 9 – Weld Both Jam Nuts to the Turnbuckle

7. Using a Lincoln Powerwave 350 Flux Cored Arc Weld (MIG) or equivalent, apply a **17mm long weld the length of one turnbuckle flat on each jam nut** (Figure 9).

Welding Power Supply:	Lincoln Powerwave 350	Electrode Manufacturer:	Lincoln Electric	Torch Angles  
Program:	Mode # 6 FCAW-S (Standard CV)	Electrode Type:	NR-211-MP (AWS E71T-11)	
Robot Description:	N/A	Electrode Diameter:	0.035"	
Electrical Stickout:	10 - 12 mm	Polarity:	DC Electrode Negative Part Positive	
Purge Time:	0.25 sec	Shielding Gas Mixture:	N/A	
Hot Start:	N/A	Shielding gas flow:	N/A	
Travel Speed:	Manual 5 ipm approx.	Torch Type:	Tregaskiss	
Voltage:	19 Volts	Nozzle Dia:	N/A	
Wirefeed Speed:	200 ipm	Weave Data:	N/A -Stringer Only	
Amperage:	140 -150 amps	Joint Design:	2F - 3F	
	N/A	Arc Transfer Type:	Constant Voltage (MIG)	Travel Angle 5 Degree Drag (+ 5 Degrees - 0 Degrees) Work Angle 45 Degrees from Turn Buckle
	N/A	Leg 1 Material Thickness:	N/A	
	N/A	Leg 2 Material Thickness:	N/A

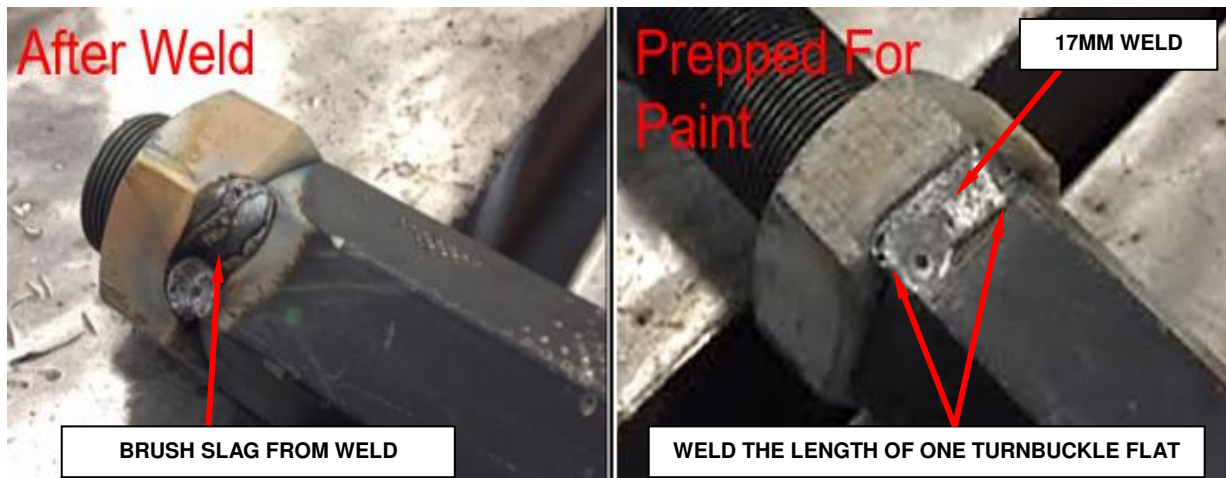
Figure 10 – Prepare areas for Paint

8. Wire brush the slag from the surface of the welds (Figure 10).
9. Allow to cool to room temperature.

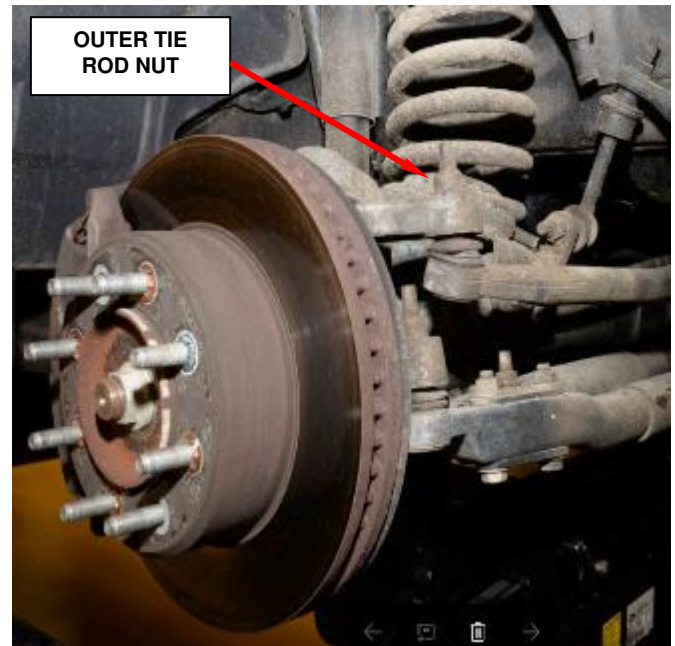
**Figure 11 – Outer Tie Rod**

1. Raise and support the vehicle.
2. Remove the right front tire and wheel assembly.
3. Remove and **DISCARD** the outer drag link to tie rod nut (Figure 11).
4. Remove the outer drag link tie rod from the knuckle using C-3894-A (puller shown in Figure 12).
